Appendix III Project 3

Rekow Stream and Riparian Restoration

Conceptual Design

Site Description

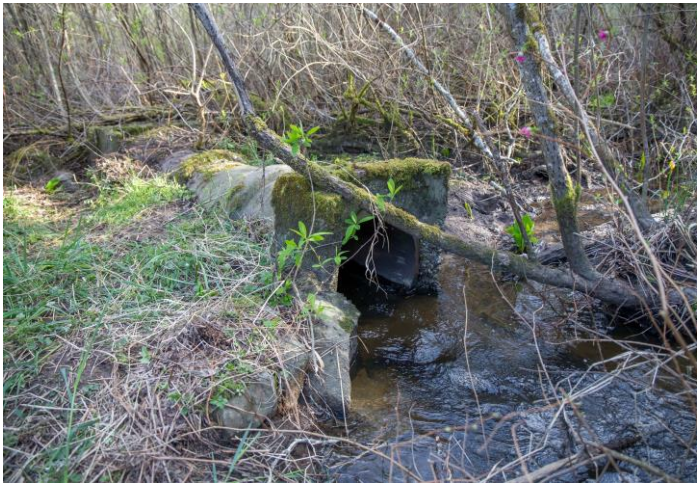
1.

Photo 1: Culvert Outlet.

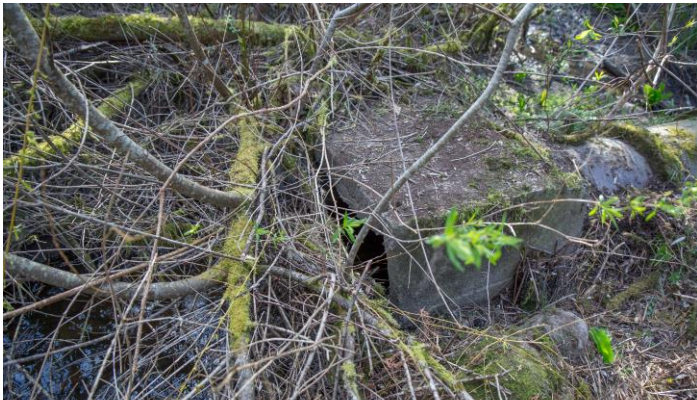
2.

Photo 2: Culvert inlet – box is disconnected from concrete culvert pipe.

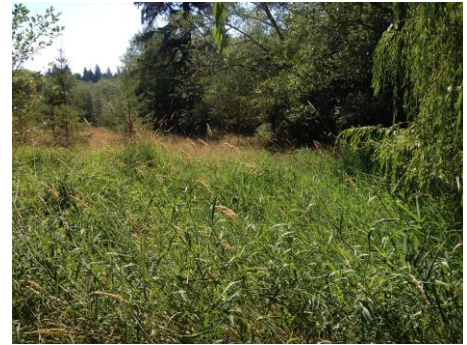
4.

Photo 4: Reed canary grass on right bank of stream below culvert

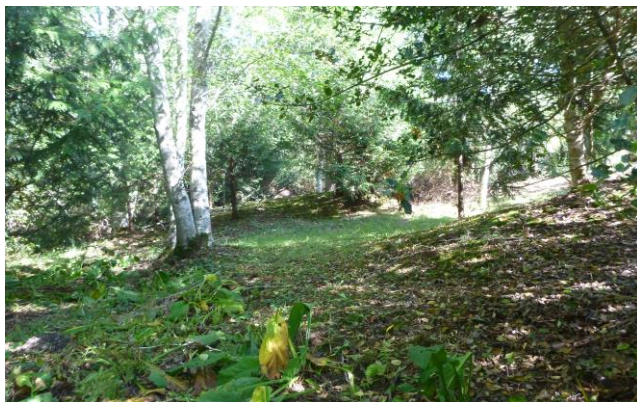
3.

Photo 3: Riparian Stream condition below culvert
