Springbrook Creek Watershed Assessment

FINAL REPORT December 26, 2018 SRFB Project #14-1517

Washington Recreation and Conservation Office Salmon Recovery Funding Board
Project #14-1517, Springbrook Creek Evaluation and Feasibility

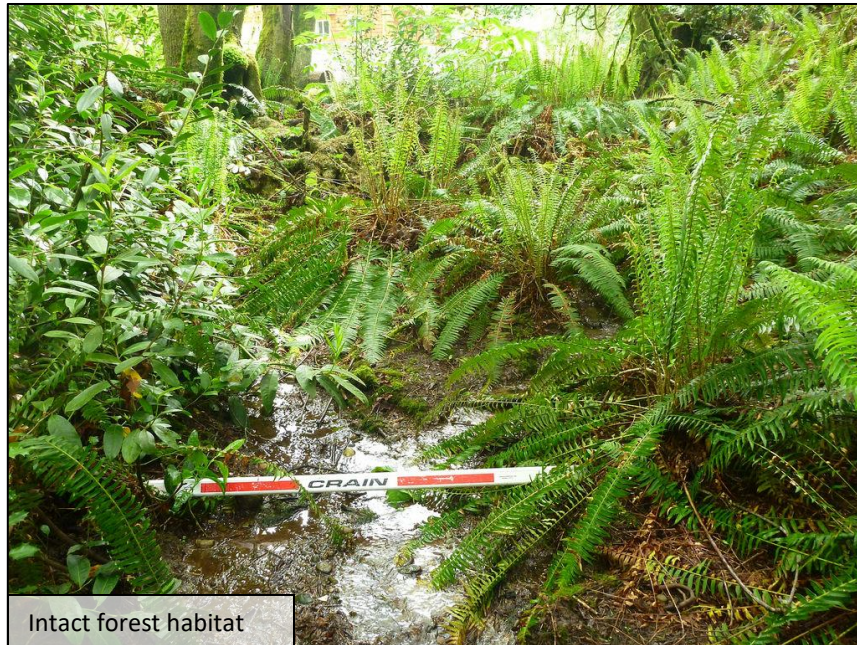
Tributary SB01A runs through Assessment Unit 2 (AU2) and consists of approximately 4,000 ft. of stream channel, of which 1,500 ft. meet physical criteria for type F (fish) habitat. The stream originates from a seasonal spring head in a shallow forested ravine. It runs down the ravine with an average bankfull width of 2.8 ft. with an average gradient of 10%. The stream then leaves the ravine, passes under a private drive, and feeds into a small man-made pond. The pond's outflow flows back under the same private drive emptying into a downstream wetland (which is not mapped in the City of Bainbridge Island's GIS wetland layer). This wetland drains into a ditch which passes under Holly Farm Lane NE. Below the crossing SB01A runs down a forested hillside with an average bankfull width of 1.9 ft. with an average gradient of 4%. The stream then flows under another private drive, is ditched along a lawn, and then feeds into a small forested wetland (also unmapped). Below the forested wetland, the stream's average bankfull width increases to 2.7 ft. running with an average gradient of 6%. This section of stream meets the physical characteristics of type F habitat. The type F channel runs down a forested valley though dense patches of English ivy. It then passes under Miller Rd NE. in a full barrier culvert. The outlet to this crossing was found 400 feet to the west of the culvert inlet where it empties directly into the right bank of Springbrook Creek at stream mile 0.06 with a 1.7 ft. tall perch. No fish were found in this stream.

- Limiting factors include poor stream and riparian conditions, altered hydrology, fish passage barriers, commercial use. This reach provides marginal fish habitat and seasonal flow and stream restoration efforts would have minimal impact on fish resources. Low impact development practices and retaining vegetation to assist with stormwater runoff will help reduce water quality impacts to the lower section of SB01 (the main stem). See Project 18, Section 6.1.2. No instream fish restoration actions are recommended in this reach of the stream.

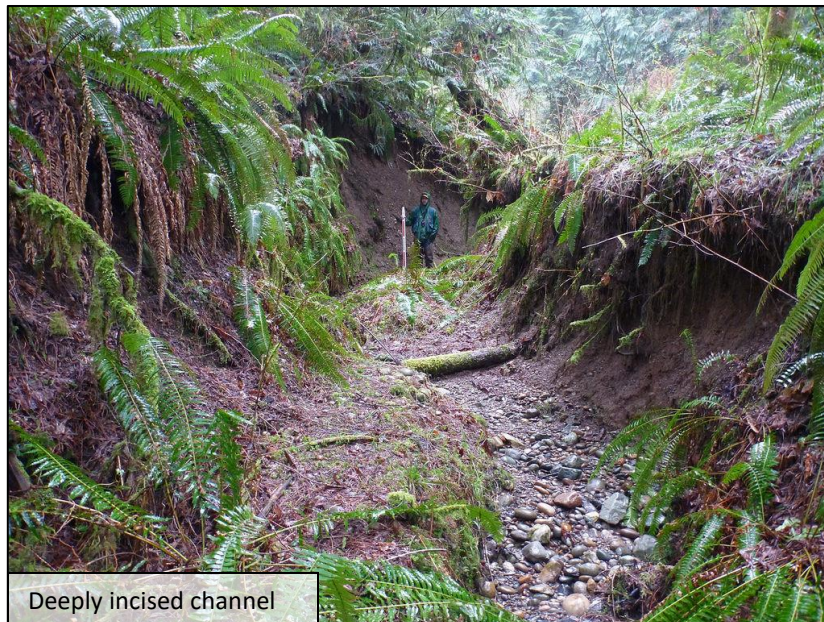
Tributary SB01B runs through Assessment Unit 3 (AU3). This tributary is approximately 2,000 ft. long, providing perennial type N waters to mainstem Springbrook Creek. The stream originates in a forested ravine where it passes under two private driveways. Below the crossings SB01B continues down the forested ravine becoming incised in a naturally confined channel with an average bankfull width of 2.5 ft. running over an average gradient of 18%. Approximately 1,000 ft. below the headwaters the stream flows under a derelict forested access road in an undersized culvert which is perched 9.3 ft. The channel below the culvert is deeply incised with mass wasting present on both banks. The average bankfull width in this lower section of the forested valley is 3.1 ft. with an average gradient of 10%. Flows were intermittent during the time of survey on March 3rd 2014. Approximately 600 ft. below the derelict culvert the stream passes under NE Mitchell Ln. Below this crossing the stream runs over 300 ft. of steep gradient averaging 18% with an average bankfull width of 3 ft. Below the steep section of channel the stream disperse into a forested wetland before it enters the left bank of Springbrook Creek (SB01-1).

- Limiting factors include high road density, and sediment inputs caused by a 9.3 ft perched derelict culvert which is responsible for severe down-cutting and erosion. Intact habitat prior to entering SB01-1 provides wetland function protection opportunities. See Project 3a.

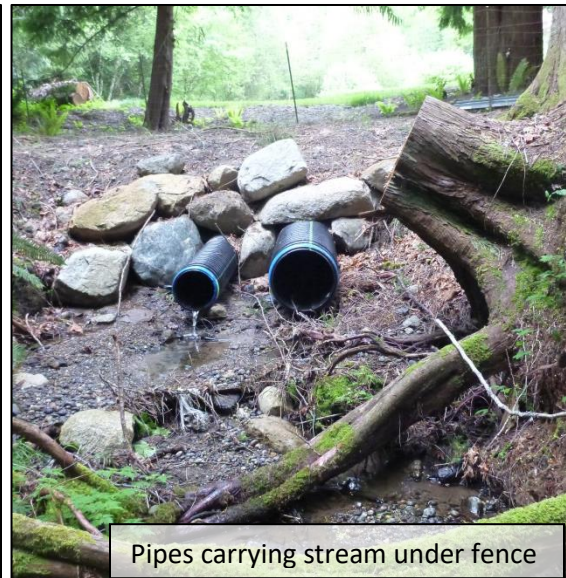
Pipes carrying stream under fence

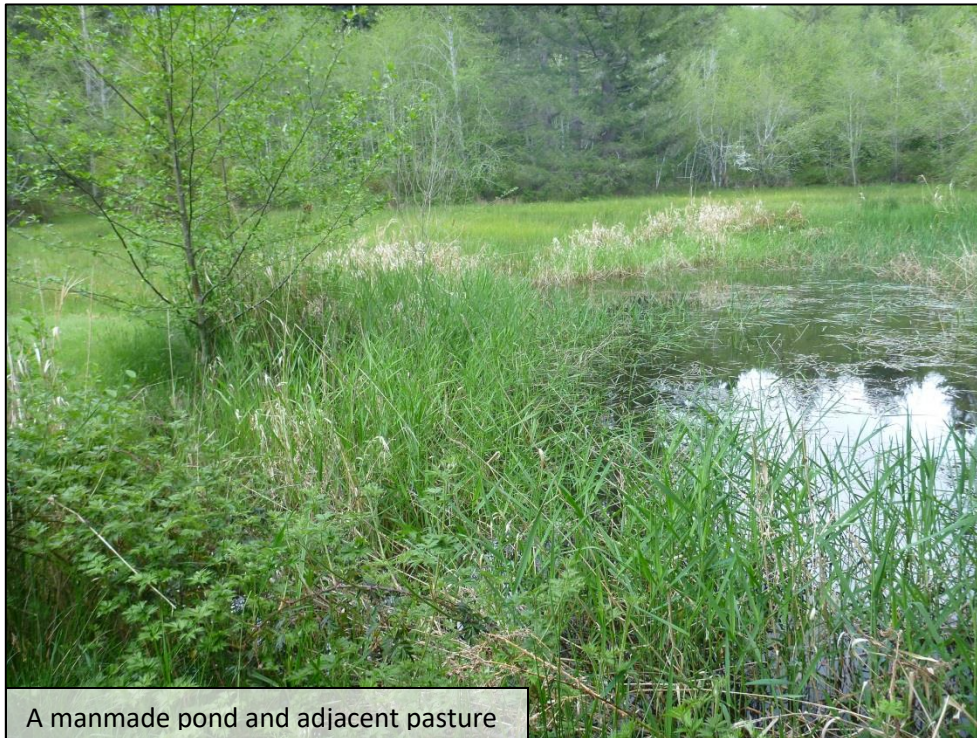
A manmade pond and adjacent pasture

Tributary SB01E runs through Assessment Unit 4 (AU4). Two small streams and their associated wetland complex feed this tributary. The left bank stream emerges from a springhead on a forested hillside. This spring feeds a type Ns stream that runs down the forested hillside with a discontinuous channel and intermittent flows. The average bankfull width of this reach is 1.7 ft. and the average gradient is 4%. The stream definition is completely lost at the base of the hill where it enters a wide forested wetland with a dense brushy understory. The forested wetland drains into a long glide which feeds into a small 0.1 acre manmade pond. This lower section of channel is type F habitat with a 20 ft. wide unconfined bank and a gradient less than 1%. A right bank stream also feeds the small manmade pond. The headwaters of this stream were not surveyed and their exact location and extent are unknown. Where the stream was surveyed it ran down a ditch-line in a field with an average bankfull width of 1.9 ft. and an average gradient

- Limiting factors include loss of natural in-stream and riparian habitat in the ditched portion and the partial barrier culvert under Fletcher Bay Road NE. Restoration of the ditched channel would be beneficial, particularly in conjunction with addressing the Fletcher Bay Road NE culvert as part of the Project 7 High School Road x Fletcher Bay Road NE area culvert and stream improvements.

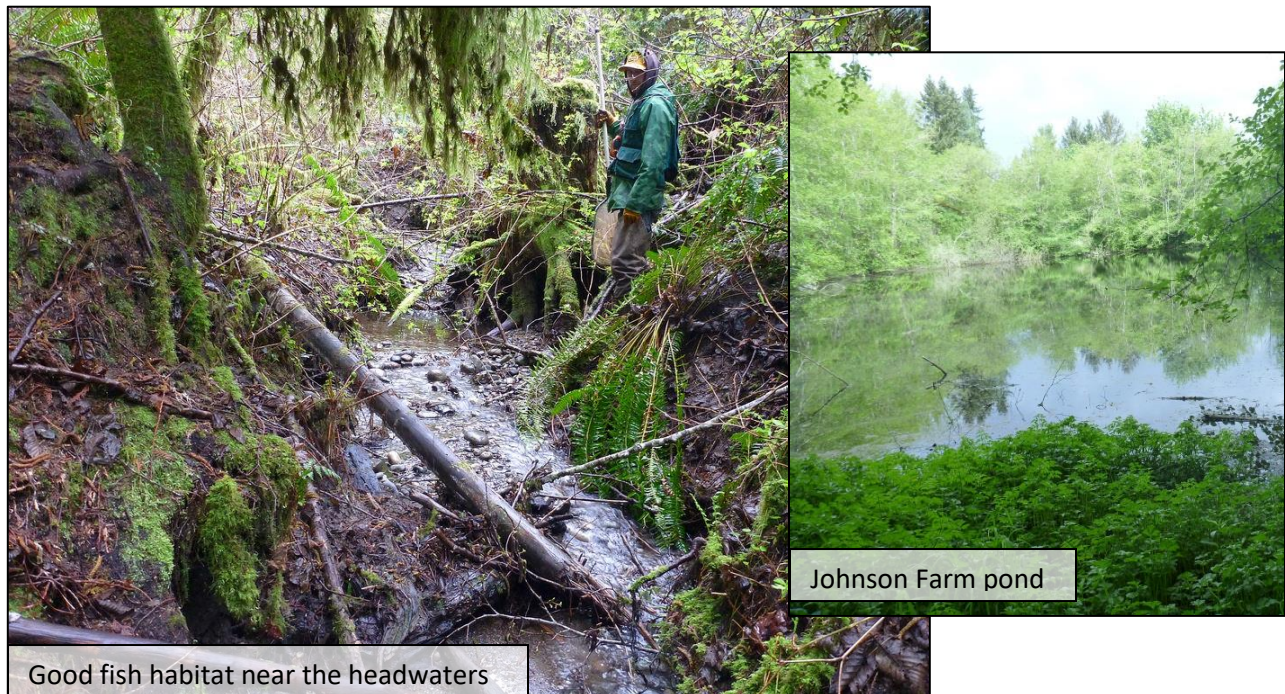
Tributary SB01F South Fork Springbrook Creek

South Fork Springbrook Creek SB01F runs through Assessment Unit 7 (AU7). The total length of this stream is 4,500 ft. with 2,800 ft. providing type F habitat. The stream originates in headwater wetlands on the south side of NE Marshall Road. The wetlands drain under the road and feed into a small type Ns stream running down a forested valley with a dense brushy understory and an average bankfull width of 1.7 ft. with a 4% average gradient. As the stream continues down the forested valley the bankfull width increases in size. Approximately 1,800 ft. below the headwater wetlands the channel runs through a forested ravine with an average bankfull width of 6.5 ft. and an average gradient of 6%. This reach flows through an intact riparian corridor, providing pool - riffle habitat, large woody debris, and excellent cutthroat spawning gravels. Then, 2,700 ft. downstream from the headwaters the stream leaves the ravine and enters a 0.72-acre shallow manmade pond on the Johnson Farm. This pond drains under NE Twin Ponds Road via an

enclosed pipe and catchment basin into a second 0.71-acre manmade pond through a stand pipe which functions as a full barrier to fish passage. The outlet of the lower pond was not surveyed and its barrier status is unknown. Below the second pond, the channel is incised with an average bankfull width of 4 ft. as it runs through a stand of alders infested with English ivy. SB01F then feeds into yet another man made pond 0.08 acres in size. Here, it joins the type F tributary SB01G. The pond drains onto a thick plastic sheet armored with riprap forming a cascade approximately 5 ft. tall. Below the pond, the stream is channelized along the edge of a lawn with riprap armor along both the left and right banks. The stream is artificially narrow in this stretch with an average bankfull width of 3.8 ft. and an average gradient of 4%. The stream then flows under Fletcher Bay Road NE in a partial barrier culvert. Two coho were netted in the culvert plunge pool during a site visit on 10/31/2013. Below the road crossing SB01F is braided down a forested hillside with a combined average bankfull width of 7.2 ft. This tributary then feeds into the left bank of the headwater reach of Springbrook Creek.

- Limiting factors include significant alteration of the stream's hydrology through the construction of ponds, drainage control systems, underground piping, partial and full fish passage barriers, and degradation of the natural channel and riparian vegetation. Large manmade ponds contribute to increases in stream temperatures and decreases in dissolved oxygen. These factors (as further described in Section 3.6) fall outside acceptable parameters for fish in the summer months throughout most of this stream system. In-channel and riparian restoration of the degraded stream just south of Fletcher Bay Road NE would be beneficial. Replacement of the partial barrier culvert on Fletcher Bay Road NE and correction of the barrier outlets from the ponds would be very important for restoration of access to the high-quality spawning habitat above these ponds, and mechanisms for addressing the temperature increases from the large ponds should be explored (Project 14).

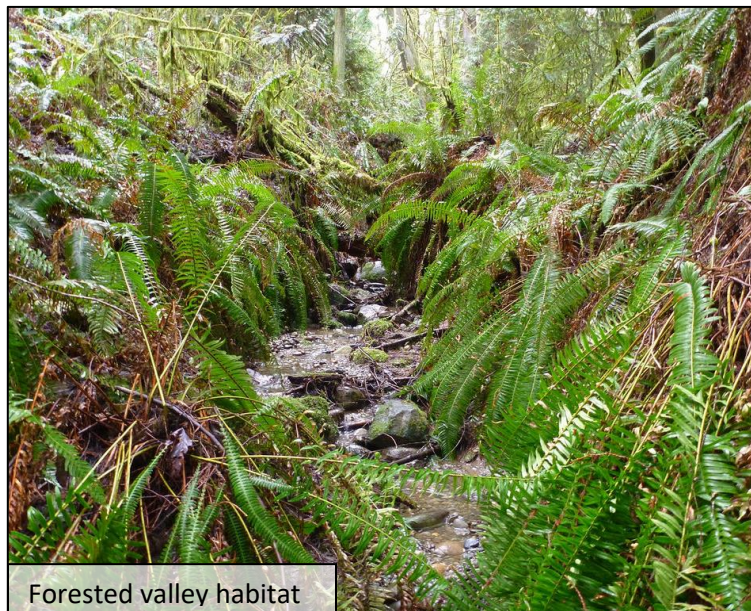
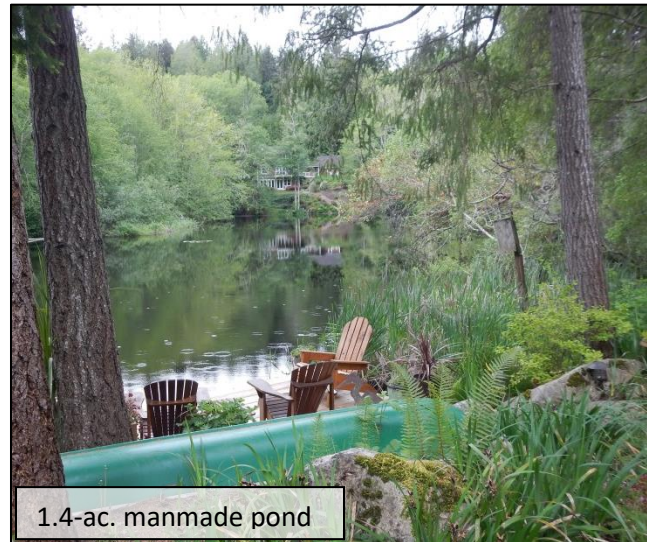
Forested valley habitat

Tributary SB01G runs through Assessment Unit 7 (AU7) with a total stream length of 2,800 ft. of which 2,200 ft. provide type F habitat. The stream is fed by a small wetland that drains into a ditched and straightened channel running along a private driveway. The channel flows under the driveway then enters a forested valley. This headwater reach is type Ns with an average bankfull width of 1.8 ft. with an average gradient of 4%. As the stream runs down the forested valley the bankfull width gradually increases as additional springs feed into the channel. At approximately 600 ft. below the headwaters the streams physical measurements qualify it as type

F habitat. Below this point the stream averages a bankfull width of 5 ft. with a gradient of 11%. Then, 1,350 ft. below the spring head the type F channel is joined by a type Np left bank tributary. The combined flows cross a private road in a full barrier, undersized, culvert perched 2.2 ft. Below this culvert the stream continues down a forested ravine with an intact riparian corridor, providing pool riffle habitat, large woody debris, and excellent cutthroat spawning gravels. A second left bank tributary joins SB01G approximately 200 ft. downstream from the crossing. 400 ft. below this confluence the stream enters a 1.4-acre manmade pond surrounded by developed and landscaped private residences. This pond has two outflow locations. The primary outflow is located on the eastern end of the pond where water enters a stand pipe with an old control valve. This stand pipe is a full barrier to fish migration. Below the pond outlet the stream runs down a lawn in an armored and landscaped channel completely devoid of instream complexity and canopy cover. The landscaped section of channel runs for 300 ft. before feeding into a small 0.08 acre manmade pond where it joins with SB01F. The secondary outflow to the 1.4-acre pond is located on the northern edge pond and drains into SB01C. The entirety of SB01G and SB01C was likely the historic drainage path of this stream prior to the construction of the pond.

- Limiting factors include significant alteration to the natural hydrology of the stream, full and partial passage barriers, a large manmade pond that increases water temperature, blocks fish passage, and alters the historic water flow, and degradation of habitat below this pond. Planning for restoration of habitat in this area requires consideration of long-term goals and consequences of retaining the current configuration which funnels the majority of year-round flow to the northeast to join with SB01F and flow into the mainstem of Springbrook Creek east of Fletcher Bay Road NE, versus restoring the historic flow path into SB01C and into the main channel over 2,500 feet further northwest (Projects 13abc). Replacement of the perched partial barrier culvert on the private drive upstream of the pond could be beneficial to resident fish, and to anadromous fish if the downstream barriers are first addressed.

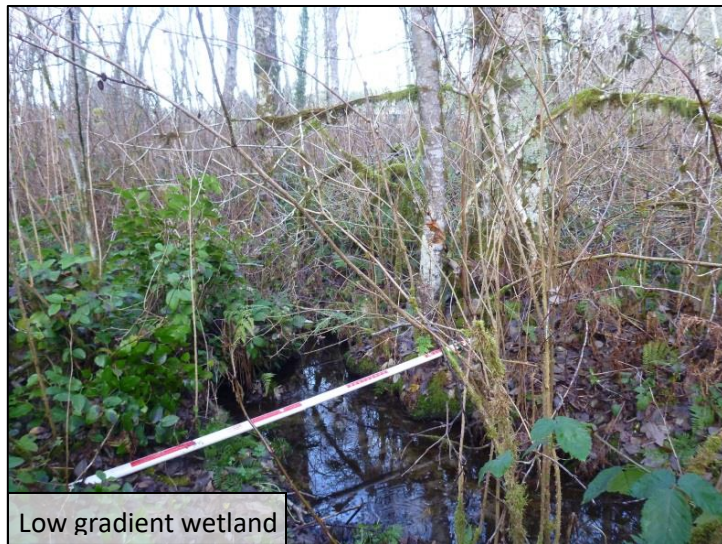
Upper Springbrook Creek SB01-2

While a good majority of Upper Springbrook Creek mainstem was surveyed, the headwaters were not, due to lack of landowner permission. Their full extent and habitat characteristics remain unknown, although the Washington Department of Natural Resources has an additional 1,500 ft. of type N channel mapped above the uppermost surveyed reach (just upstream of the adjacent coho and cutthroat detections in SB01-2 in Figure 17). The upper extent of water typing surveys conducted by WFC found Springbrook Creek meandering down a low gradient forested wetland valley with an average bankfull width of 5 ft. and an average gradient of 1%. This section of channel provides excellent potential rearing habitat with sandy sediments, undercut banks, and large woody debris. Approximately 500 ft. downstream from the upper end of the survey the stream flows under a derelict forest access road crossing. The culvert at this crossing is very steep, forming a full barrier to fish migration. Below the crossing the stream continues down the wide valley bottom with a deciduous canopy and a dense understory dominated by salmonberry. A coho was netted in this reach during a site visit in the spring of 2016. Downstream 600 ft. from the derelict road crossing Upper Springbrook Creek enters an 80 ft. long section of channelized and armored stream channel. This short section of stream is artificially narrow with a bankfull width of 1.8 ft. Below the armored channel the stream is joined by a right bank tributary draining two man-made ponds. The combined flows cross a horse trail in two side by side partial barrier culverts. Below the crossing SB01F merges with the left bank of Springbrook. The combined flows run down a forested valley with an average bankfull width of 6.5 ft. and an average gradient of 2%. This section of channel provides excellent fish habitat with numerous pools, undercut banks, and excellent spawning gravel. This stream reach is the upper extent of documented coho spawning and is the transition point from AU6 to AU4. Below this point the stream is described as SB01-1, Middle Springbrook Creek.

- This is largely an intact, functioning stream reach with good habitat protection opportunities (see Projects 11 and 12). Limiting factors for fish access to habitat are a partial barrier culvert and full barrier culvert. The former is proposed for replacement under Project 9 (Section 3.4.5) and the latter for removal under Projects 10 and Project 11 (Conceptual Design Project Rolling Bay Property Culvert Removal and Riparian Protection).

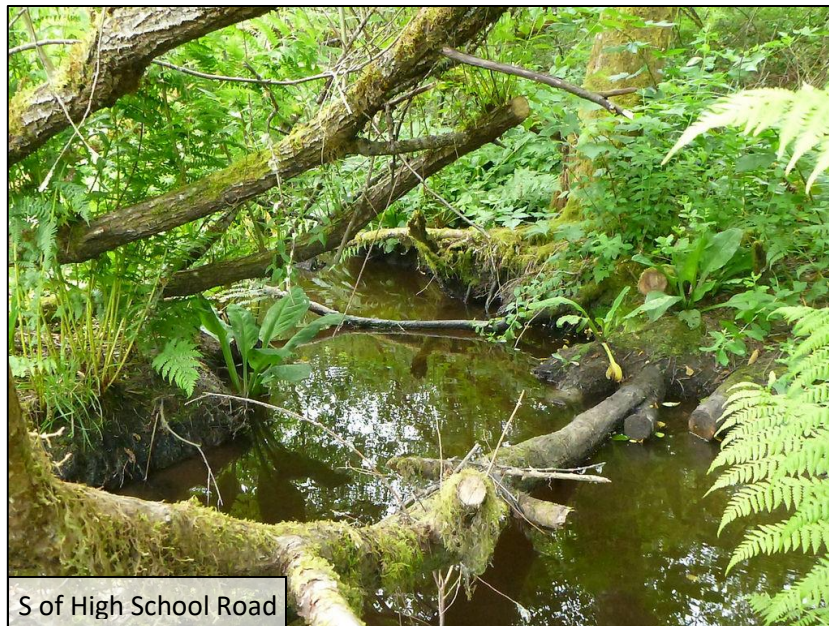
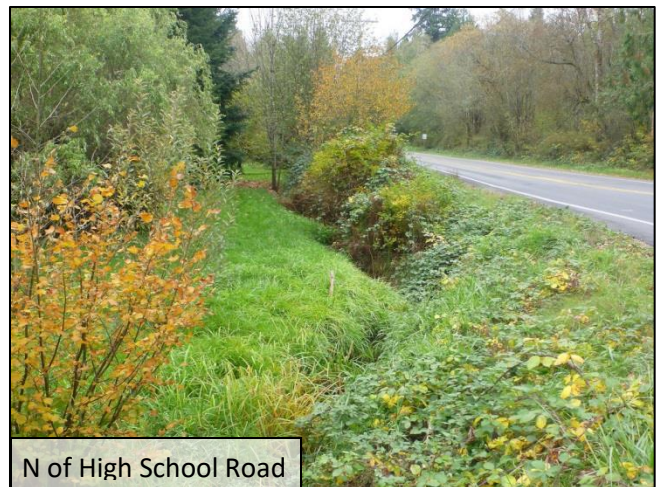
Middle Springbrook Creek. SB01-1

The middle section of Springbrook Creek flows through Assessment unit 4 (AU4) through a wide unconfined valley with a large wetland corridor. The total stream length of middle Springbrook Creek is 2,800 ft., all of which is Type F habitat. The reach begins on the south side of High School Road, where the valley becomes unconfined and flows meander through high-quality forested wetlands with an average bankfull width of 7 ft. and an average gradient of 1%. The substrate here is dominated by gravel (0.1-2" diameter pebbles), with sand increasing as the stream nears the road. The stream then passes under High School Rd in a partial barrier culvert. Below the crossing the stream is ditched along the north side of the road for 550 ft. with a predominantly sand and silt substrate and dense overgrowth of blackberry thickets. Scouring of the ditch banks is evident. The stream passes under Fletcher Bay Road NE in a 3' diameter culvert which is beginning to rust out. The frequent flooding of the adjacent property to the north evidences the size deficiency of this culvert. Coho and cutthroat trout were netted in the outflow pool below this Fletcher Bay Road culvert. Continuing down from the culvert, the stream is channelized down a narrow strip of alders for 175 ft. before feeding into a 0.5 acre man-made pond. At the pond outlet there is a fully fish-passable log weir control structure. Below the pond the stream continues down a narrow strip of alders, with an average bankfull width of 7.5 ft. and an average gradient of 1%. This reach is homogenous, lacking instream complexity. Approximately 450 ft. below the pond the SB01D tributary enters the right bank of Springbrook creek.

The combined flows continue down the channelized stream corridor on the north side of a horse pasture. Springbrook Creek is then joined by SB01C, a left bank type F tributary 500 ft. downstream of the confluence with SB01D. In this area the landowner planted trees to help provide shade to the stream. Below the confluence with SB01C Springbrook Creek meanders down an unconfined low gradient valley bottom through adjacent wooded wetlands with an average bankfull width of 6.3 ft. and an average gradient of 1%. Here, the left bank of the valley floor is densely forested with an over story of alder, ash, mature willow, and red osier dogwood. The right bank of the valley has been cleared of native vegetation and is currently dominated by invasive reed canary grass. Springbrook Creek runs within the left bank forested section for 450 ft. providing excellent low-gradient salmonid rearing habitat with undercut banks and instream large woody debris. The stream then leaves the forested habitat running into the recently cleared valley bottom. For approximately 250 ft. the stream is choked with reed canary grass. Below the cleared section of stream Springbrook Creek flows under a wire mesh fence and enters wooded wetlands densely populated with alder, mature willow, and red osier dogwood. Approximately 400 ft. below the cleared area the creek flows under a derelict field access road in a partial barrier culvert. Below this crossing the valley becomes more confined and the stream gradient increases from an average of 1% to 3%. Here the substrate changes from sand and silt to gravel and cobble. This demarks the transition from middle Springbrook Creek SB01-1 to lower Springbrook SB01.

- Limiting factors in this mainstem reach include clearing of native riparian vegetation and replacement with invasives, alteration of stream channels and funneling into a ditch alongside a major road and under an intersection of two main Island arterials (with associated pollutants), loss of stream complexity in additional areas, and partial fish passage barrier culverts. As noted under section 3.6 below, there were also detections of human fecal bacteria in this reach, and actions to find and address these sources are needed. There are many opportunities for riparian restoration (including Conceptual Design Projects 3 and 4), and protection of important wetland functions. It is recommended that the entire High School Road x Fletcher Bay Road NE area be considered as a coordinated suite of culvert and stream improvements as per Project 7.

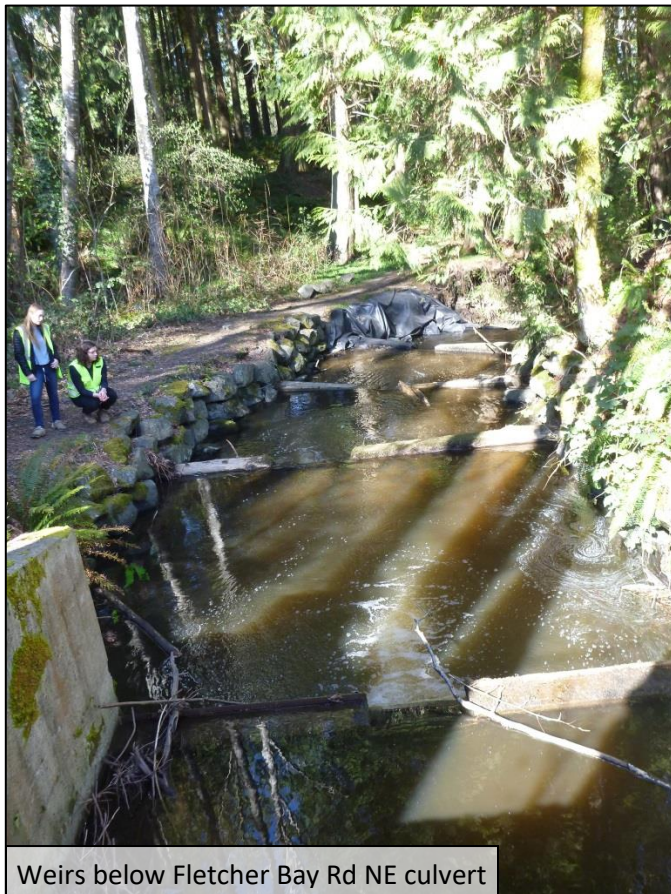
Weirs below Fletcher Bay Rd NE culvert

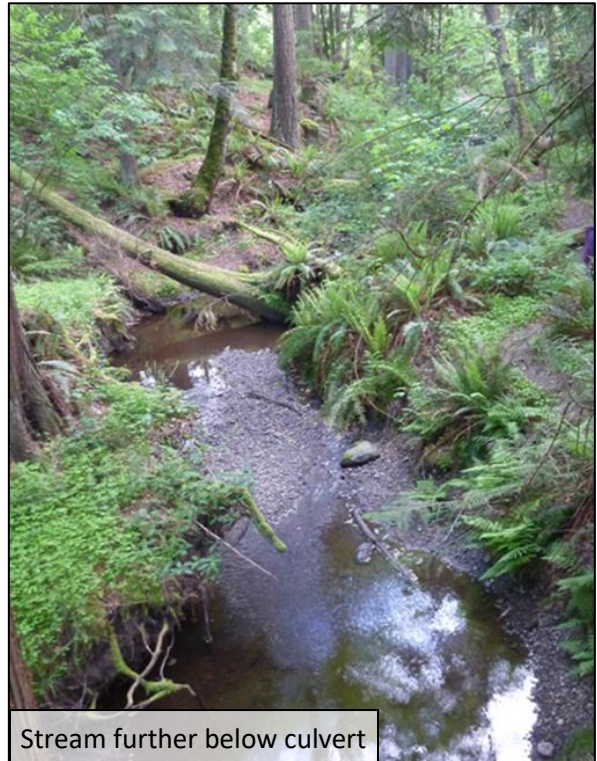
Stream further below culvert

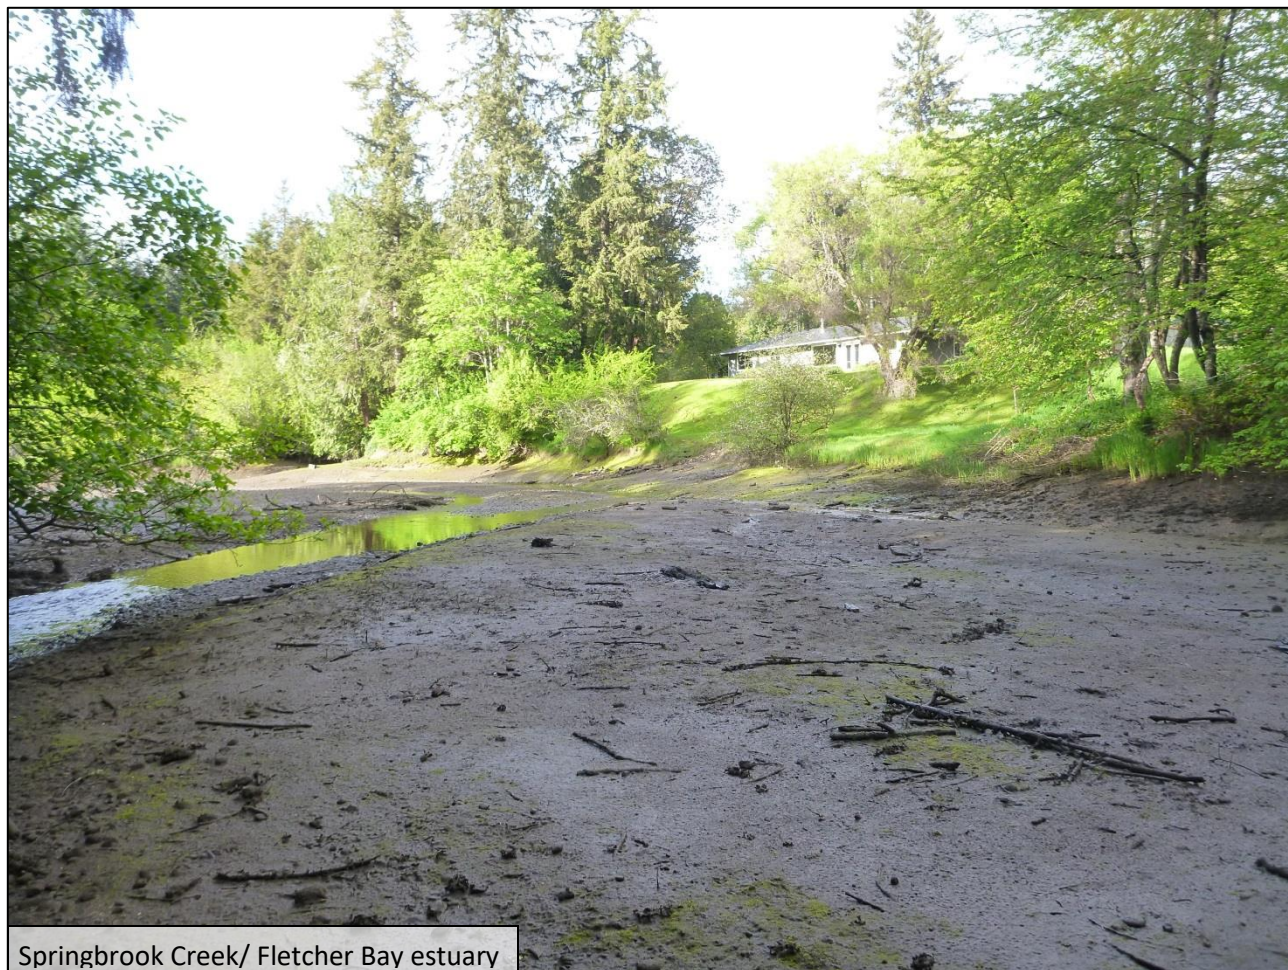
Springbrook Creek enters Fletcher Bay Estuary at its southeastern extent, with Issei flowing in just north of this confluence. Sediment from these two streams contribute to a large mudflat area exposed at low tides, with lesser contributions from the smaller seasonal creeks entering closer to the mouth of the estuary (North Fletcher Bay Creek flowing from north and Foster's Creek from the south). Fletcher Bay Estuary was placed on the State's 'Threatened' list of shellfish growing areas in 2013 due to high levels of fecal bacteria. Subsequent work by Kitsap Public Health found decreasing levels of bacteria from 2013-2016 (Walther 2016), and as reported under Water Quality (Section 3.6), most recent samples detected moderate levels of human and ruminant source fecal bacteria in this reach.

Springbrook Creek/ Fletcher Bay estuary

- Limiting factors for this reach include streamside armoring, loss of channel complexity, and an undersized culvert and failing weir system acting as a fish passage barrier, and one additional fish passage barrier culvert. Given the concentration of development within this watershed, additional limiting factors include high road densities and high proportion of the area in impervious surfaces. Although water quality monitoring (Section 3.6) did not detect high levels of metals during the monitoring period, this is an area with high risk of contaminants flushing into the stream in stormwater events, and bacterial contamination persists. Removal of armoring and streambank restoration (see Project 2, Appendix III: Eddy) and replacement of undersized culverts and the failing weir system (Project 1, Appendix III: Fletcher Bay Culvert) would be very important actions given the location near the outlet of the stream system. Protection of intact habitat is also important here, as are actions to improve stormwater infrastructure to prevent pollutants from reaching the stream system (Project 18).

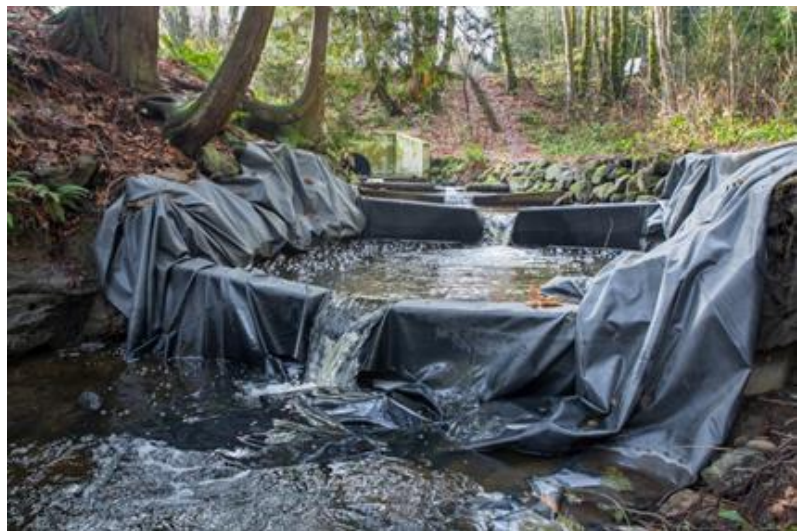
water now passes through a crack in its foundation and through large rocks armoring the bank rather than spilling over the top of the weir. The City of Bainbridge Island has installed plastic sheeting and sandbags to temporarily restore fish passage function to the lowest weir. WDFW identifies this complex as 33% passable and has assigned it a Prioritization Index (PI) of 24.66 (WDFW culvert ID #15-0340); this is amongst the highest PI's of 44 PI calculations that WDFW has performed on Bainbridge Island. This crossing affects fish access to 3.6 miles of fish habitat upstream. Below the failing weir the channel is incised and scoured down to hardpan for approximately 200 ft. potentially affecting spawning habitat. The entire 999 acre Springbrook Creek watershed drains to this location.

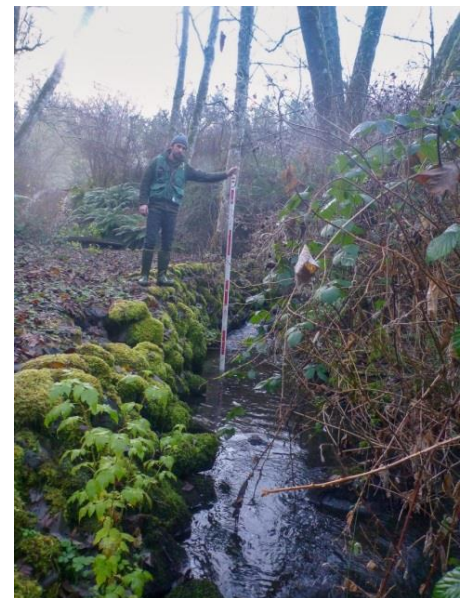
Appendix III Project 2

At river mile 0.39 Springbrook Creek crosses a field access road on a 14.58 acre parcel belonging to Barbara Eddy. Above the crossing, Springbrook Creek runs through a forested valley with an average bankfull width

of 9.5 ft. and the average gradient of 2%. 3.4 miles of fish habitat exist upstream from this crossing. The stream is carried beneath the field access road in a 4 ft. round corrugated steel pipe 40 ft. in length. WDFW has identified it as a 67% passible partial barrier culvert due to the fact that it is undersized and has a slope of 1.68% and has established a priority index (PI) of 19.86. Approximately 100 ft. downstream from the culvert there is a long section of riprap armament protecting a picnic area on the right bank. This armored section of channel is artificially narrow and has caused substantial scour of the unprotected left bank. The armored channel also lacks instream complexity forming a 70 ft. long continuous riffle with neither pools nor large woody debris. A footbridge at the upper end of the right bank riprap has additional armor protecting its left bank foundation. Below the armored section of the channel, Springbrook Creek enters a lush forested valley with excellent pool-riffle habitat.

The project team rationale for recommending this project as the #2 project within the Springbrook Creek Watershed included: project's location low in the watershed, its adjacency to project #1 (Fletcher Bay Culvert/Weir Removal) and project #3 (Rekow Stream Restoration), improving the following limiting factors: fish passage, riparian habitat, sediment transport, instream complexity designed to support fish life stages (large wood transport and restoring stream to its historical profile and gradient and more pools and riffle), stream hydrology, and landowner willingness. Landowner Barb Eddy was deeply involved in the design discussions and allowed full access to her property in order to perform due diligence necessary for formulating restoration ideas. Additionally, the project team focused on sequencing projects moving upstream from Fletcher Bay. This project is the second lowest barrier in the creek system, making it a priority to address in the near term order to provide access to 3.4 miles of upstream fish habitat.

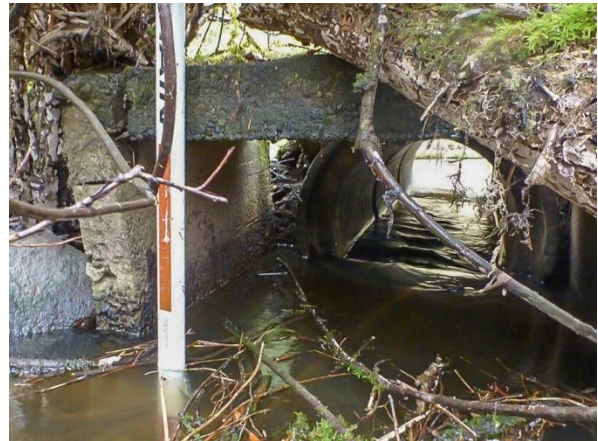
Washington Department of Fish and Wildlife has assigned a priority index of 21.82 to this culvert. A small type F stream feeds into the left bank of Springbrook Creek at the culvert outlet. Above the culvert crossing Springbrook Creek meanders down an unconfined valley bottom through adjacent forested wetlands with a bankfull of 6.8 ft. Below the culvert crossing the valley becomes more confined. The left bank of the downstream valley below the culvert is forested with a mixed stand of conifers and deciduous trees. The right bank valley below the culvert is primarily a grassy field with scattered pockets of skunk cabbage and other wetland vegetation, trees and a thin strip of shrubs growing along the creek. Some reed canary grass and other invasive plants are mixed in with native vegetation. Some native vegetation has been mowed or reduced on the right bank (perhaps by past livestock use).

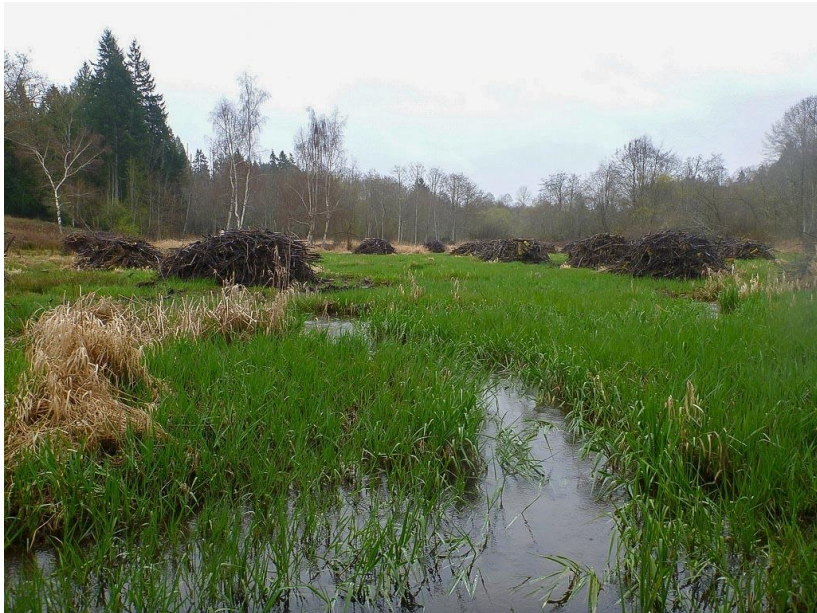
Springbrook Creek runs along the southwestern edge of a 5.88 acre parcel belonging to Will and Cathy Nickum. In this reach, the stream meanders down an unconfined low gradient valley bottom of approximately 1.5 acres with adjacent wooded wetlands with an average bankfull measurement of 6.3 ft. The left bank of the valley floor is densely forested with an over story of alder, ash, mature willow, and red osier dogwood. The Nickum property is located on the right bank of the channel. The

right-bank portion of the valley has been cleared of native vegetation and is currently dominated by invasive reed canary grass. The stream exists wholly within the Nickum parcel at this time. The associated wetland forest and upland riparian area uphill of the left bank of the stream is owned by three separate landowners and is comprised of intact mature mixed forest and wooded wetlands.

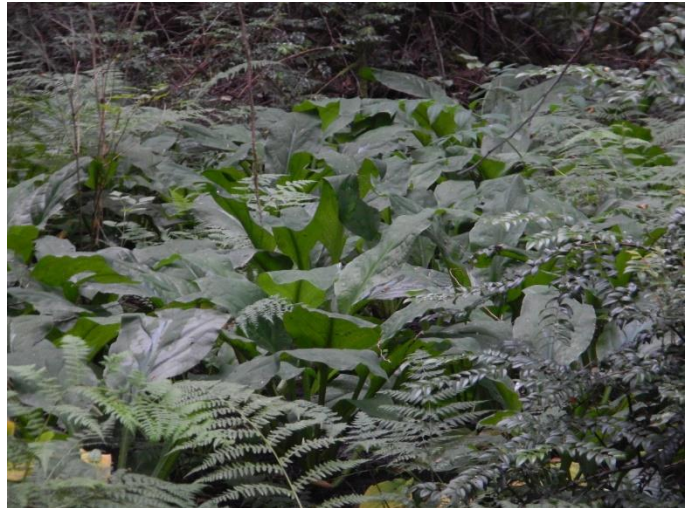
Coho and cutthroat have been documented within this reach of the stream and downstream, and there is excellent potential for fish rearing habitat within the AU. There is mature riparian vegetation hydrologically connected to the stream.

The Upper Springbrook Creek tributary is characterized by a large wetland complex, native vegetation which provides shade to the stream and food for a number of birds and other animals. The stream width varies from 6 feet in width with a defined channel to a narrow approximately 2 foot channel within a large wetland complex. The stream runs year round. Due to the large undisturbed wetland complex, the Washington Department of Ecology's Watershed Characterization identified this AU as particularly important for providing water recharge and discharge functions thus keeping this functioning wetland protected is important to overall watershed health.

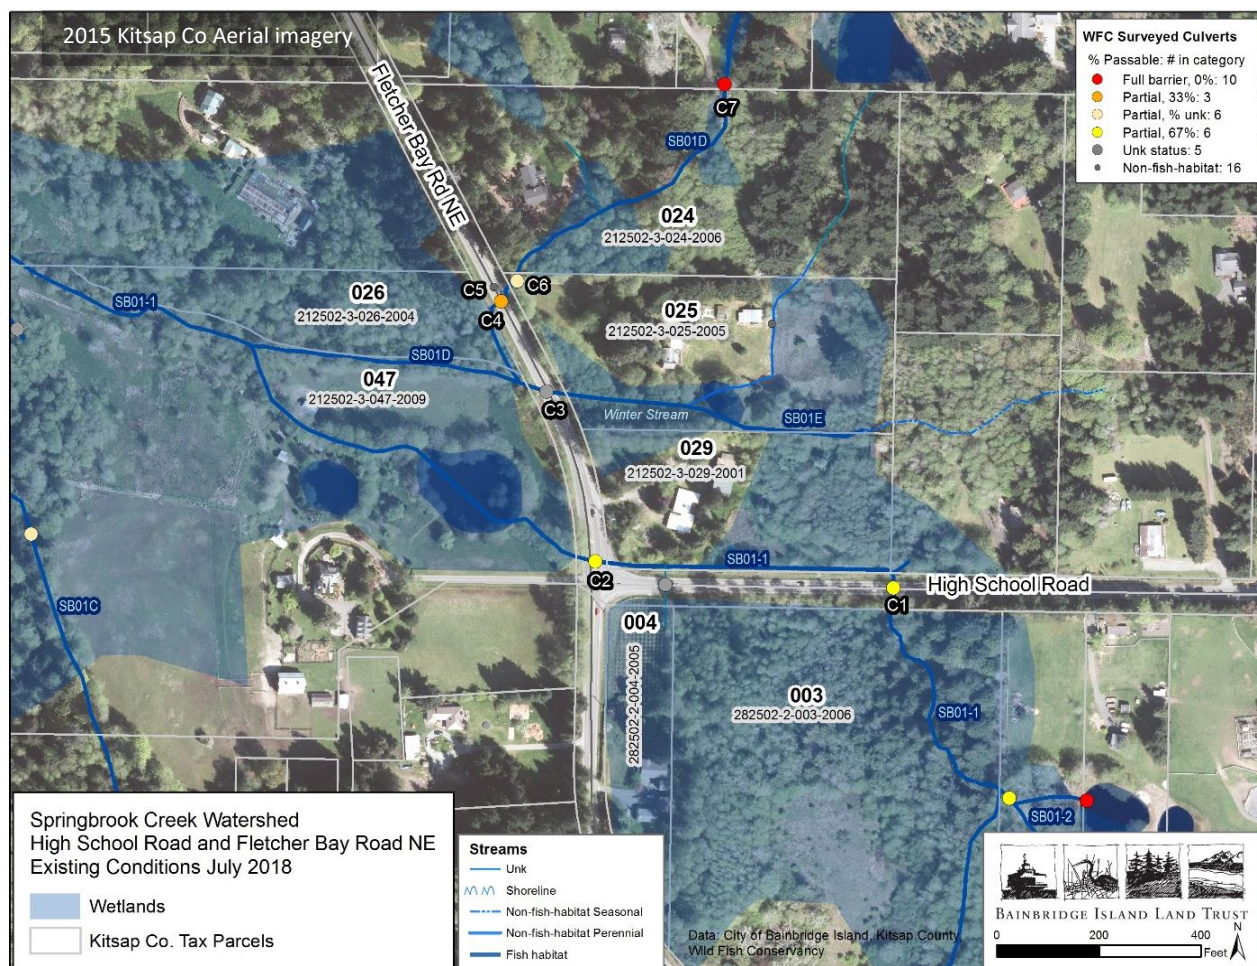
Figure 34. Existing Conditions

The intersection and proximity of Fletcher Bay Road NE and High School Road is a nexus of complicated problems arising from past engineered solutions, stream modifications, multiple stream channels, roads, and existing land use. The area includes drainage from four assessment units (AU 4, 5, 6, and 7) – draining approximately 600 acres of the 999 acre Springbrook Creek watershed. There are seven culverts (Figure 34) that partially or fully block fish passage under, adjacent or in proximity to the main roads in this intersection area, and several are in need of replacement to address fish passage, stormwater, and aging infrastructure. The stream reaches of SBO1D, SBO1E, SB01-2, SB01F and portions of SB01G and SB01-1 flow through this area. There are seven individual landowners who live on the stream or in the proximity of the stream.

Instead of addressing a number of issues individually (Project id's 5,6,7,8 on Figure 32) the project team strove to formulate alternatives for addressing the entire suite of issues in this area as an interrelated whole. The project team had numerous site visits and conversations with affected landowners, and utilized data gathered on culverts, water quality, and historic channels in conjunction with high-definition elevational models (1m LIDAR). As further described in Appendix IIIF, four alternatives were designed to affect greater restoration of stream health and fish habitat quality by addressing limiting factors of: impeded fish passage; degraded riparian conditions; invasive plants; constrained floodplains; high stream temperatures; unfiltered stormwater runoff from roads to the stream; and degraded aquatic life conditions, while contributing to overall watershed function, meeting landowners' needs, addressing failing infrastructure, reducing the number of culverts, and restoring lost wetland habitat. These four alternatives all address major issues such as the channeling of the creek through a perched culvert under High School Road into a blackberry-choked ditch, and replace or obviate the need for undersized culverts (Figure 35), but differ in the degree to which they separate the stream from roads, the location and number of remaining culverts, and the patterns of water flow.

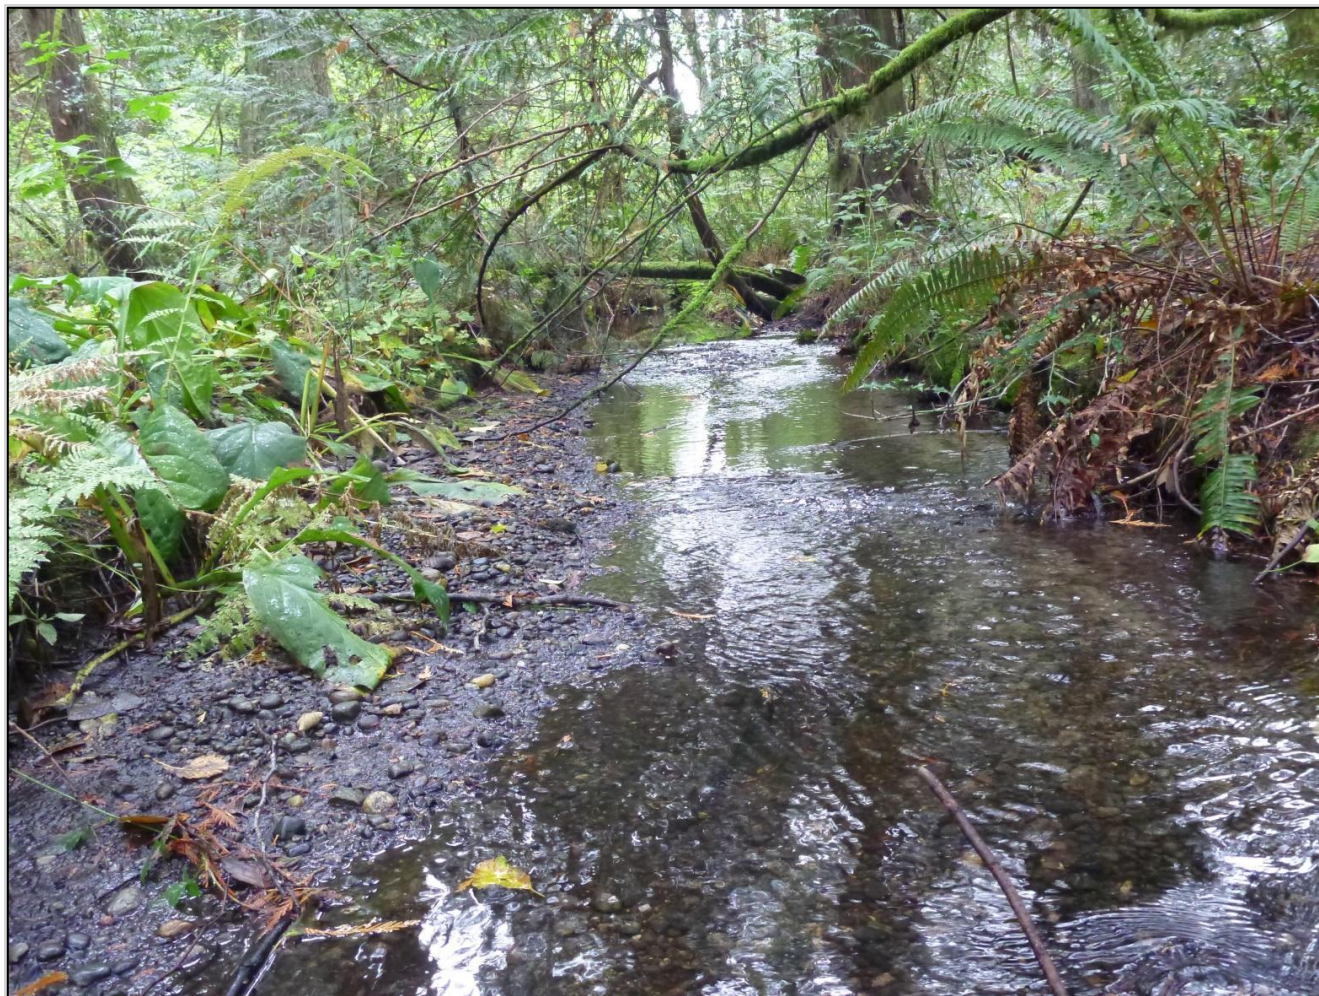
Figure 39. High-quality stream conditions and riparian habitat on Potential Project 12.

Potential Project 12 (Kitsap County Tax Parcel 282502-2-003-2006) is a 12.87-acre parcel owned by a conservationist landowner who has worked with the Land Trust in the past on purchases of, and Conservation Easements on, her properties. This property was once part of the Anderson Farm as well as a homesite, with just remnants of an old house next to an old clearing remaining. The riparian and wetland areas are in very good condition (Figure 39), with the stream meandering in braided channels through mature forests. Permanent protection mechanisms for the property we have discussed with the landowner could include a Conservation Easement with the conservation area covering the entire area, or retaining a development footprint to allow redevelopment of the southern portion around the old homesite.

Establishing more permanent protections for the wide wetland band between Potential Project 12 and Potential Project 11 (Appendix III Project 11: South East Fork Springbrook Creek Protection Conceptual Design) could be highly beneficial. Habitat on Kitsap County Tax Parcels 282502-2-055-2003 and 282502-2-056-2002 is in good, intact condition and both of these landowners have a high degree of interest in protecting the stream and wetlands. Working with these landowners to assist them in maintaining long-term habitat protections is recommended.

The three parcels immediately east of Potential Project 12 (Kitsap County Tax Parcels 282502-2-036-2007, 282502-2-032-2001, and 282502-2-002-2007, Figure 38) share a common landowner, also with a high interest in protecting fish and streams. South of the small manmade ponds, vegetation clearing inadvertently occurred within areas mapped as wetlands such that the dense deciduous forest shown in the aerial photograph (Figure 38) has been converted to scattered trees over lawn. There is also a short, small culvert passing under a footpath which was found to be 67% passable due to excessive slope (Figure 40) on Kitsap County Tax parcel 282502-2-036-2007. The stream merges with channels on Potential Project Parcel 12 immediately west of this point. The landowner wishes to enhance fish habitat and is willing to consider a

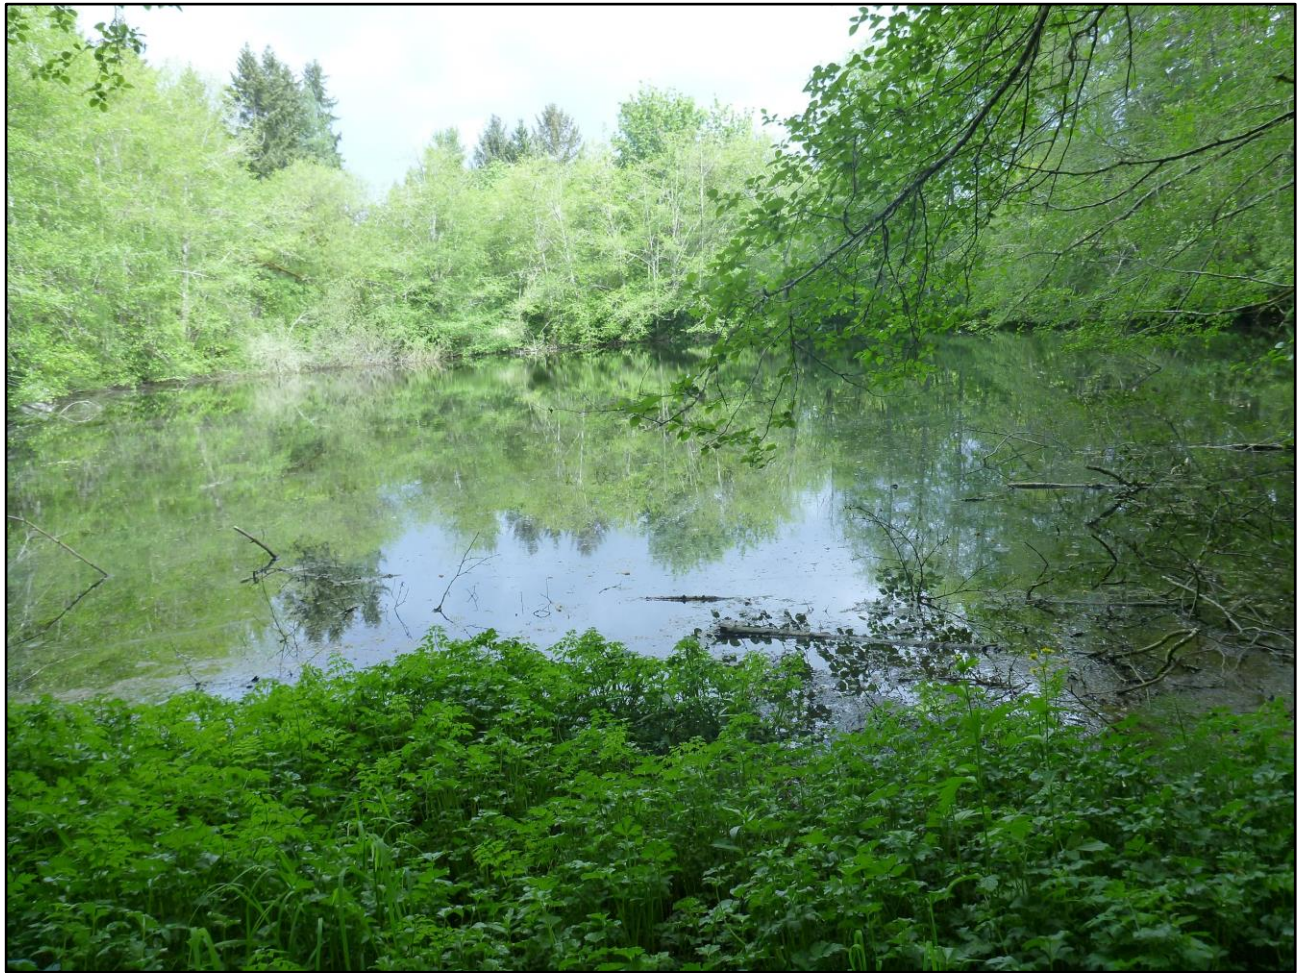
Figure 43. Johnson Farm pond.

Ponds throughout the watershed have been identified as hindrances to water quality and quantity. The pond on the City-owned Johnson farm (Potential Project 14, Figure 42) is no exception. The water quality at site Q above the pond remained cooler and more plentiful than the water quality at site D below the pond (Figure 42). Increasing the amount of baseflow throughout the summer and reducing the water temperature could be achieved by allowing the pond to naturalize and encourage buffer plantings. The main hurdle to this idea is that the pond is currently being utilized by commercial farming on the site for an irrigation source. Water lines would need to be installed from the drilled well (existing onsite) to replace this water source if the pond were to be return to its natural state entirely.
