Springbrook Creek Watershed Assessment

FINAL REPORT December 26, 2018 SRFB Project #14-1517

Washington Recreation and Conservation Office Salmon Recovery Funding Board
Project #14-1517, Springbrook Creek Evaluation and Feasibility

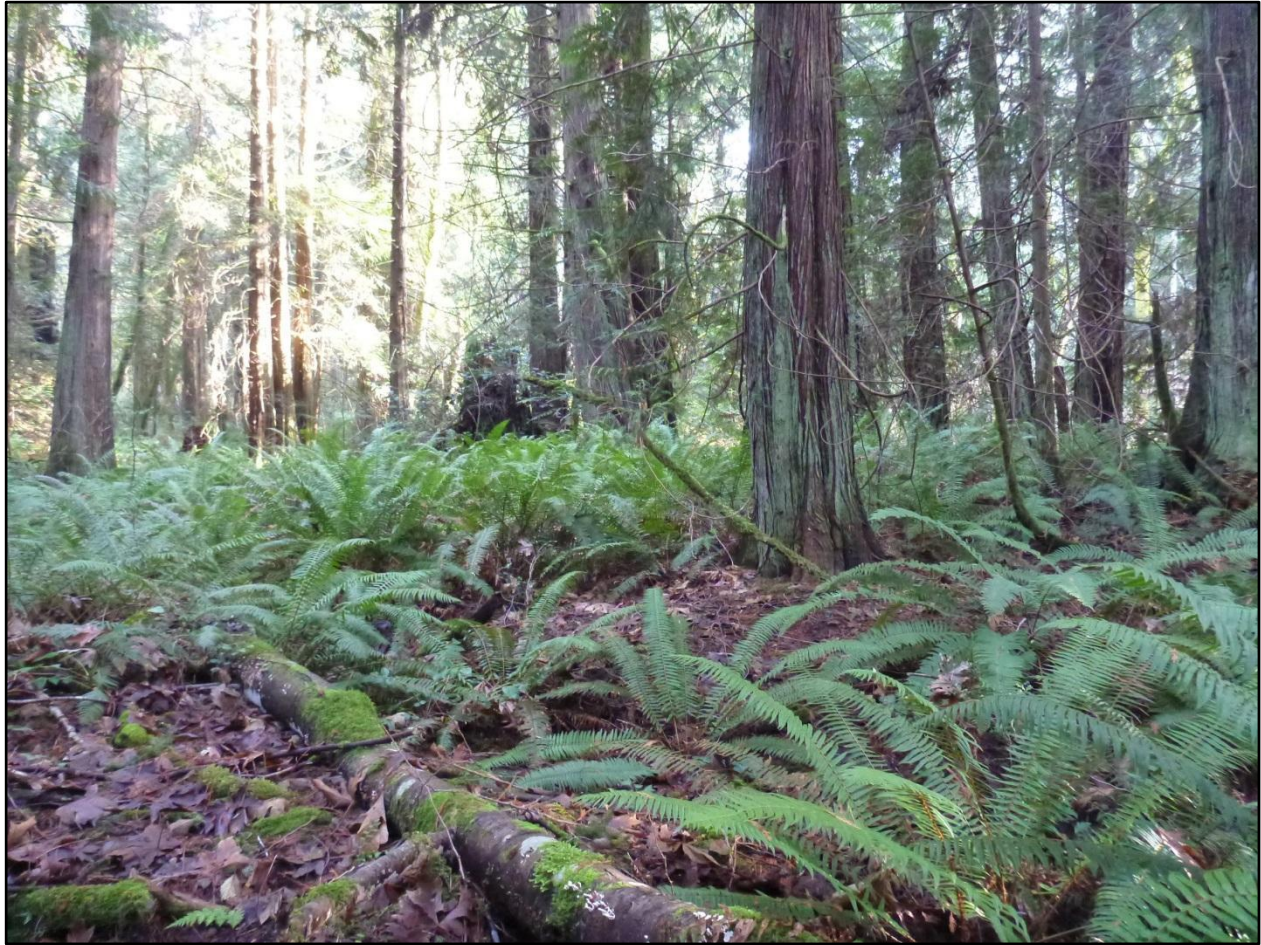
Figure 46. Mature forest along the Northeast Tributary, south of New Brooklyn Road.

About 730 feet further upstream from Greg Farm Lane, the creek winds through wetlands in a beautiful mature western red cedar and Douglas-fir forest on an undeveloped 17.5-acre parcel (Figure 44 Potential Project #15; Kitsap County Tax Number 212502-3-005-2009), above a 67% passage barrier culvert under Berganio Lane. The landowners are long-time Islanders with a deep appreciation of their lands and a combination of culvert replacement and assisting the landowners in preserving these forest habitats would be a valuable future project. In the context of Bainbridge Island, this is a substantial piece of undeveloped and unprotected forest, and protection through conservation easement or purchase would be highly beneficial to stream health and to maintenance of high-quality forest habitat in the watershed.

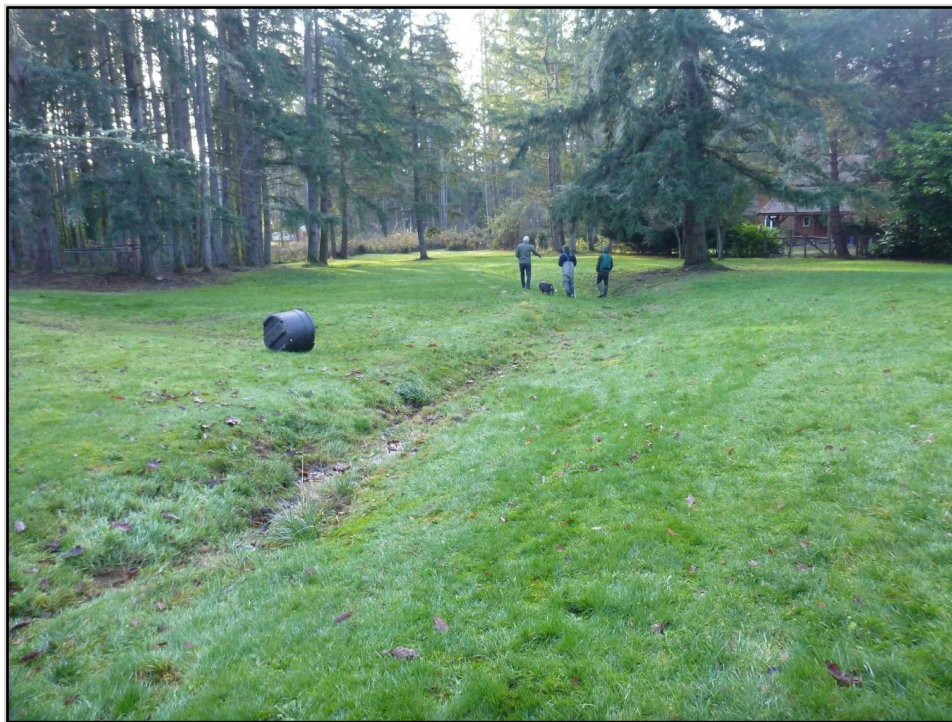
Figure 47. Northeast Tributary north of New Brooklyn Road.

North of New Brooklyn Road, the stream course between a distinct ravine at the very top of the tributary to the road is difficult to estimate from aerial photographs and was mapped using a combination of modeling from LIDAR followed by on-the-ground verification with landowners. Most of the landowners we communicated with did not consider water flowing through their properties to constitute a stream, nor was it mapped or regulated as a stream by the City of Bainbridge Island. On Tax Parcel Number 212502-2-024-2008 (Figure 44 Potential Project 16), the water (not flowing at the time of our December 2017 visit) comes into the top of the property through a culvert under a driveway. The previous owner had it flowing through a small pipe under a raised garden area, then down a ditch in the lawn into forest below the property. The current owner found flooding to be a recurrent issue, sometimes into their shop/garage building. They regraded and eliminated the pipe and attempted to make the water flow in something closer to the natural low point and no longer have flooding issues. Water now flows down a ditch along their gravel driveway, then down across the driveway in front of the shop/garage, and into the ditch through the lawn. Water flows only in rainy periods, and frequently disappears into the ground before reaching the downstream neighbor. Were fish able to access this reach, the driveway would serve as a full passage barrier.

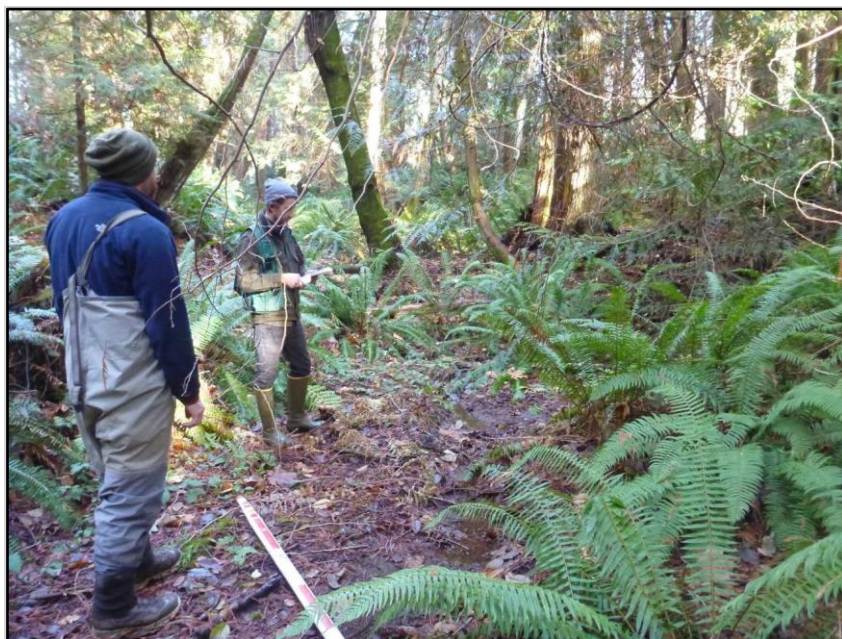
Figure 48. Excellent habitat at headwaters of Northeast Tributary, Potential Project #17.

In contrast, the property immediately upstream (Figure 44 Potential Project 17; Tax Parcel Number 212502-2-015-2009) hosts very high-quality riparian habitat along about 760 feet of typed fish-habitat stream, with ferns under large mature trees in a distinct ravine. Aside from some trails and minor clearing, development impacts are restricted to the benches above the draw. The stream transitions from seasonal fish-habitat to seasonal non-fish-habitat at the northern boundary of the property, and ends about 200 feet further upstream.

All along this tributary a key action will be informing landowners of the stream and its values as well as regulatory protections. Long-term protection of the forested ravine combined with working with the landowner directly south to restore a healthier channel and riparian vegetation would be quite beneficial to function and downstream water quality in this tributary.
