Characterization Results for Springbrook Creek Watershed

Bainbridge Island, Washington

Washington Department of Ecology

Publication 18-06-006

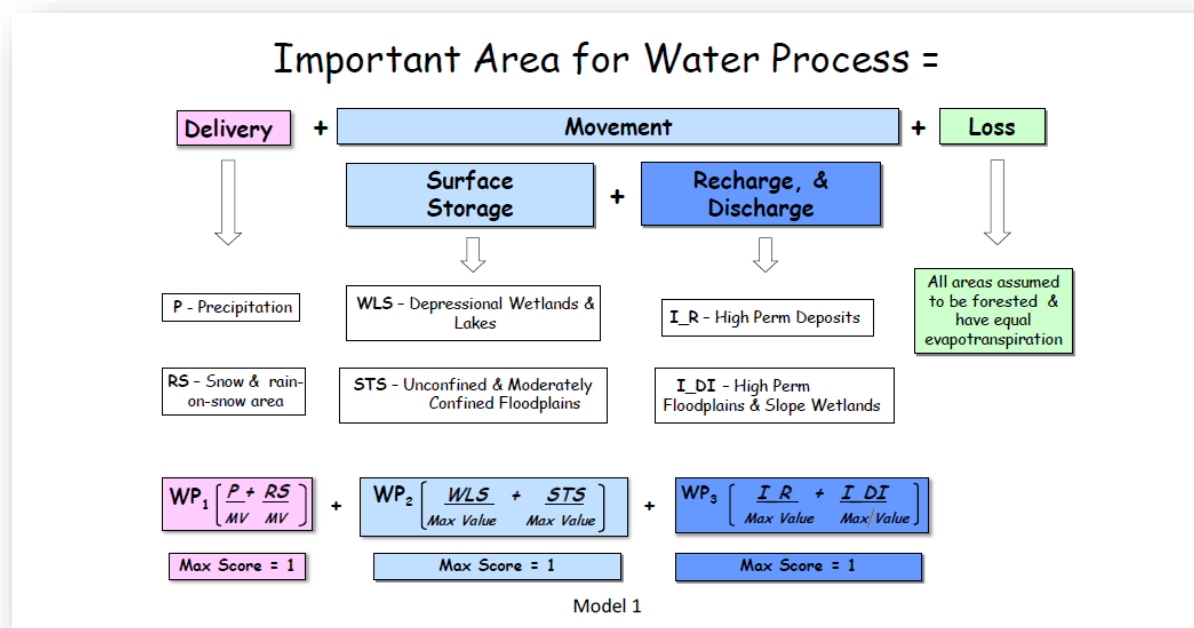
Figure 2. Diagram of the components that comprise the importance model. The physical features that control the delivery, movement and loss of water are represented by the “white boxes.” For example, a control for storage would be indicated by the presence of depressional wetlands and lakes.

The greater the number of controls within an individual PAU the higher its importance relative to other sub-watersheds within that watershed. The importance model is designed to give the user a picture of how a watershed should function without the changes or impacts created by human development over the past 150 years. Figure 2 presents the “importance” model (i.e. model 1) and the indicators that it uses of landscape features that control the delivery, movement and loss of water.

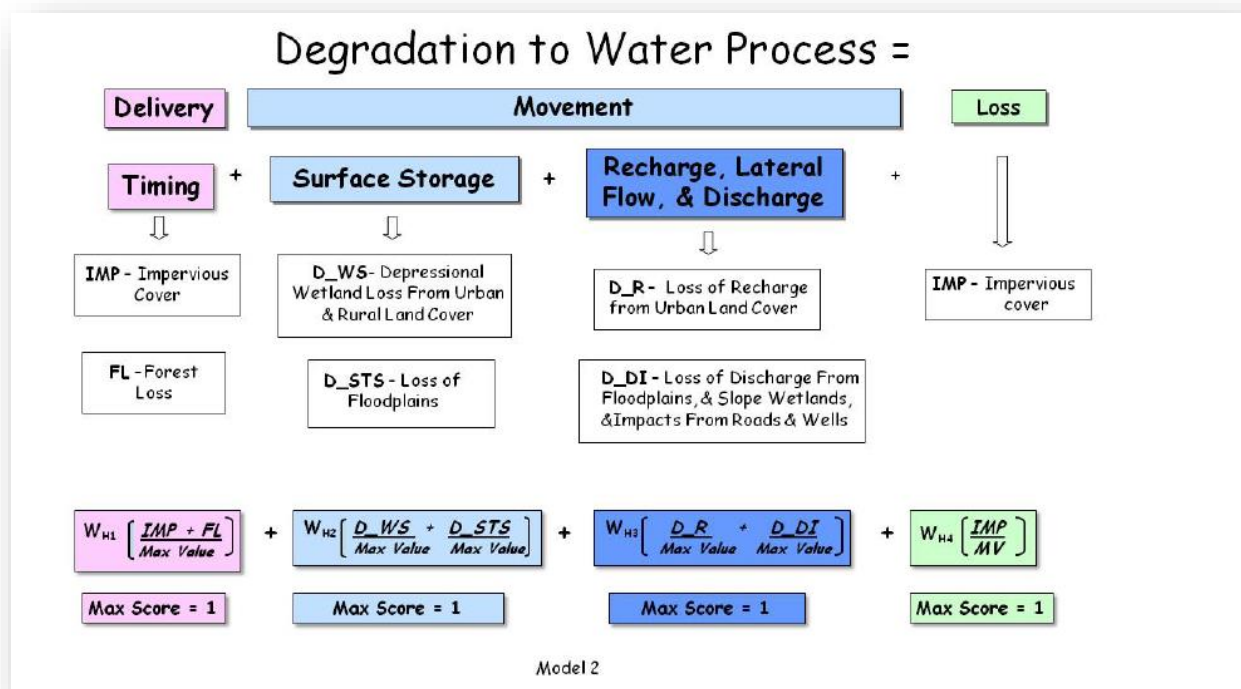
Figure 3. Diagram of the components that comprise the degradation model. The “white boxes” represent the type of alteration that would affect the controls in model 1 for the delivery, movement and loss of water. For example, the loss of wetlands and floodplains from urban development would directly affect the storage control of model 1.

In order to understand the extent of impacts to the water flow processes, the characterization uses a degradation model which is shown in Figure 3. The degradation model looks at the degree to which each of the controls for the importance model have been changed relative to those same controls in other sub-watersheds. Typically, the greater the number of controls that are altered, the higher the degradation score.

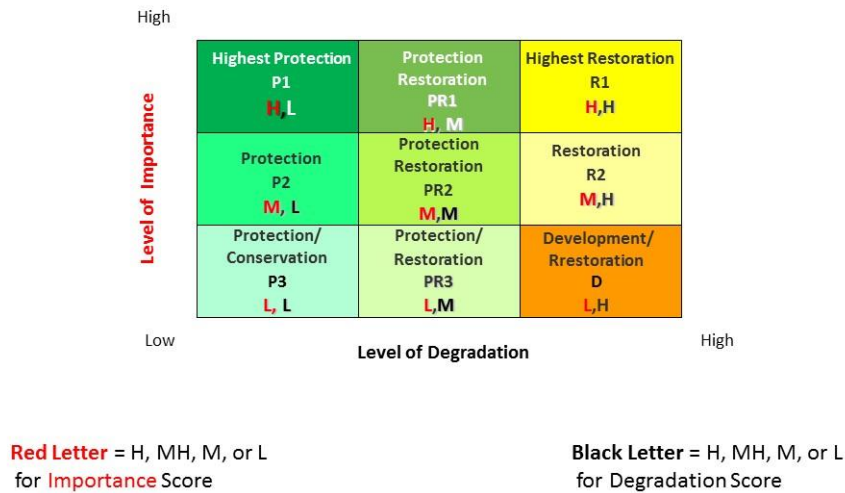
Management Matrix (9) for Protection & Restoration of Water Flow Processes with GIS Attributes

Figure 4. Management Matrix for combining the results of model 1 (level of importance on vertical axis) and model 2 (level of degradation on horizontal axis). The matrix is designed to assist resource managers in identifying the best locations and priority (e.g. P1>P3) for restoration and protection actions.

The results for both the importance and degradation model can be combined in a matrix (Figure 4) that allows a user to identify what type of management action might be appropriate for a particular sub-watershed. For example, if a sub-watershed is comprised primarily of forest cover, with little to no development, higher rainfall, and large areas of permeable deposits, then that watershed would fall within the upper left quadrant of the management matrix for “protection”. On the other hand, if a sub-watershed with high importance was highly degraded, then it would fall within the “restoration” quadrant of the management matrix. Each management action is given a priority number of 1, 2 or 3 with “1” being the highest priority for consideration (e.g. P1, protection 1, has a higher priority than P3, protection 3).

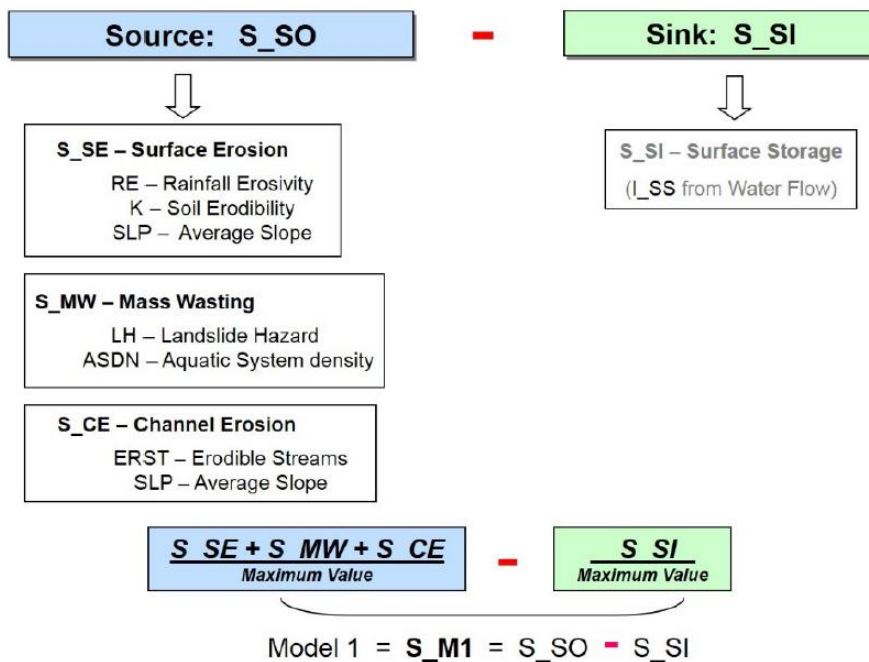
Figure 5. Diagram of the components that comprise the sediment export model. This model calculates the relative value of areas within a watershed that control sediment source and sink processes and takes the difference between those two values in order to obtain the relative export potential.

For the characterization of sediment impacts, a model structure similar to that of the water flow processes is used. This includes a model for assessing the export potential for sediment of individual assessment units. This includes identifying the features on the landscape that control the erosion of sediment sources, sediment transport and sinks which store sediment (Figure 5). For the Springbrook Creek Watershed, only the export potential for sediment was assessed and not how these sediment processes have been degraded.

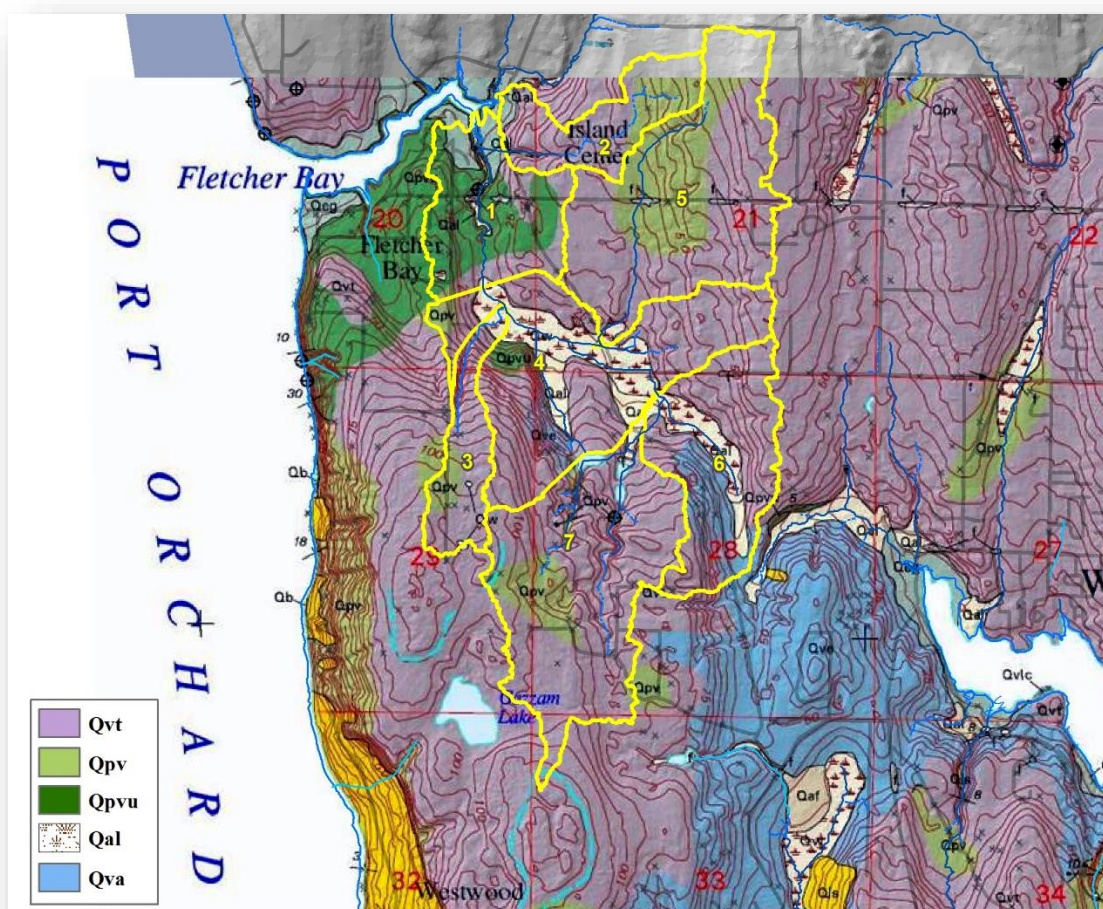
Figure 6. Surficial geology map of Springbrook Watershed. Note that the watershed is comprised primarily of low permeability till deposits (purple color: Qvt), but also contains areas of higher permeability “advance outwash” deposits (green color: Qpv) that are important for water flow processes and are primarily located in the upper watershed of Project Assessment Unit (PAU) 3 and 7 as well as in PAU 2 and 5 (Figure 8). The “white” Qal polygon is the location of depressional wetlands (PAU 4, Figure 8) which play an important role in the storage of surface waters and is also an area of groundwater discharge. Source USGS, Haugerud, 2005.

The glacial deposits on the island consist primarily of till, advance outwash and recessional outwash (Figure 6). Till is a highly compacted glacial deposit that has relatively low permeability and low potential for erosion. Advance outwash consists of sorted sands and gravels that were washed out in front of the advancing glacier. Due to compaction by the advancing glacier, advance outwash deposits are considered to have moderate permeability and water holding capacity. Because recessional outwash was not compacted by the retreating glacier, it is highly permeable and also has the highest capacity for storing groundwater.

During the May 10th field inspection, sediment fans were observed at the Johnson Farms agricultural ponds (Figure 13). Upstream of these ponds are deposits of outwash material (see Figure 6), which have a relatively higher rate of erosion. Because storms in Puget Sound are showing an increase in intensity and duration, it is important the forest cover be left in place for assessment units that have erosive deposits.

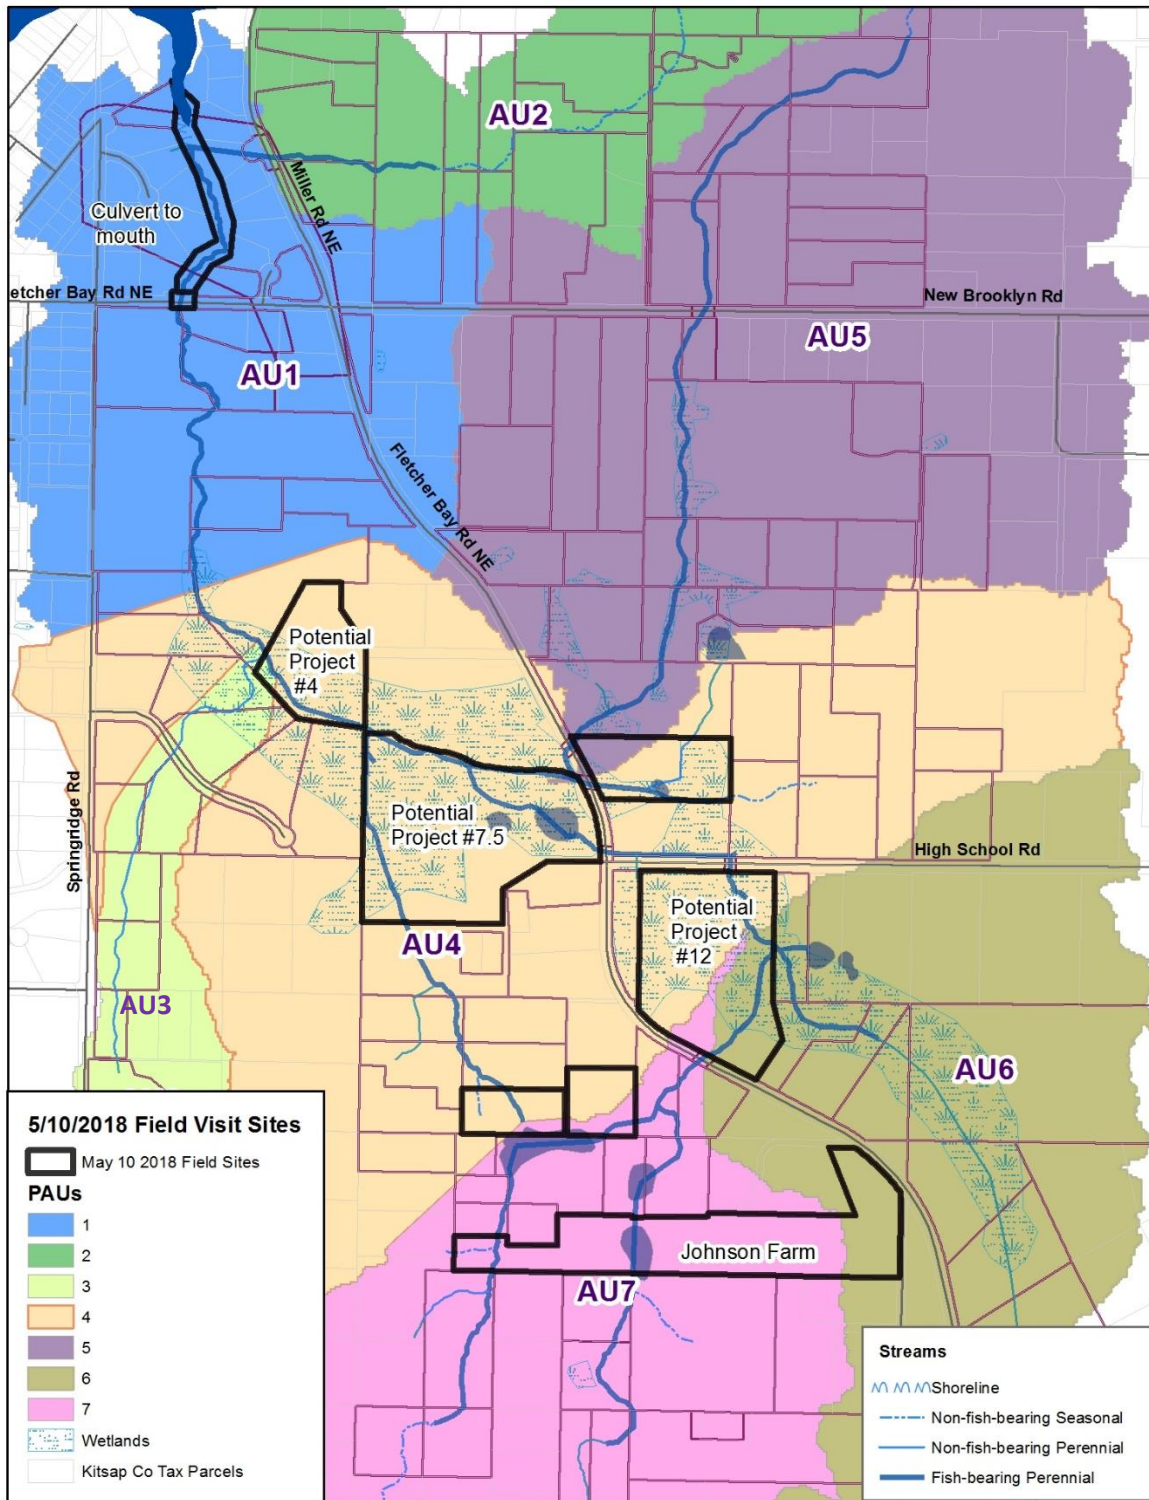
Figure 8. The Project Assessment Units (PAUs) for Springbrook Creek Watershed are shown in color and are numbered 1-7 on the map. The “Potential Projects” indicate the approximate location of properties visited during the May 10, 2018 field tour. Map courtesy of Bainbridge Island Land Trust.

Figure 11 and Table 1 present the results of applying the Puget Sound Characterization decision support tool, to 7 assessment units within the 999 acre Springbrook Creek Watershed (Figure 8).

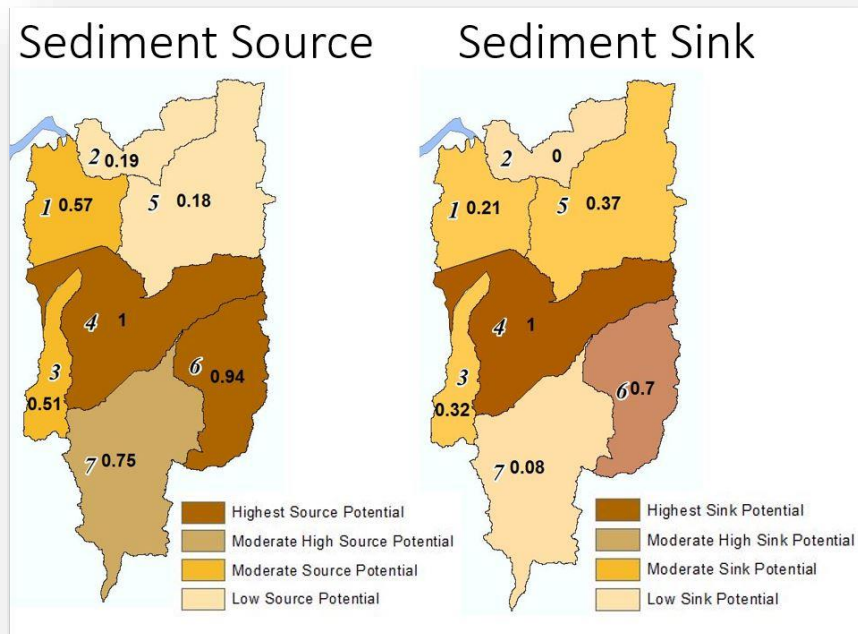
Figure 9. Results of sediment model. The left graphic shows the areas with the highest potential for generating sediment (darker colors), such as assessment units 4, 6 and 7. The right graphic shows the areas with the highest potential for retaining sediment (darker colors) such as assessment units 4 and 6.

flows contribute to supporting stream flows within these PAUs. This part of the watershed is in relatively good condition hydrologically due to an intact forest cover and limited development. This area also has a high potential to generate and export sediment (Figure 9). To minimize sediment export and protect water flow processes, primary land use management measures should include protection of land cover and minimization of impervious surfaces and provision of adequate buffers to protect stream systems.

Figure 9 also indicates that assessment units 4 and 6 have a high potential for acting as both a source and sink for sediment. These conditions suggest that the restoration and protection of depressional wetlands and floodplains in these units would be a high priority since they would be capable of retaining fine sediment. In addition, the process of adsorption in these depressional wetlands would act to remove phosphorous, metals and toxic organics. Primary land use management measures would be to restore the storage and water quality processes and functions in these PAUs.

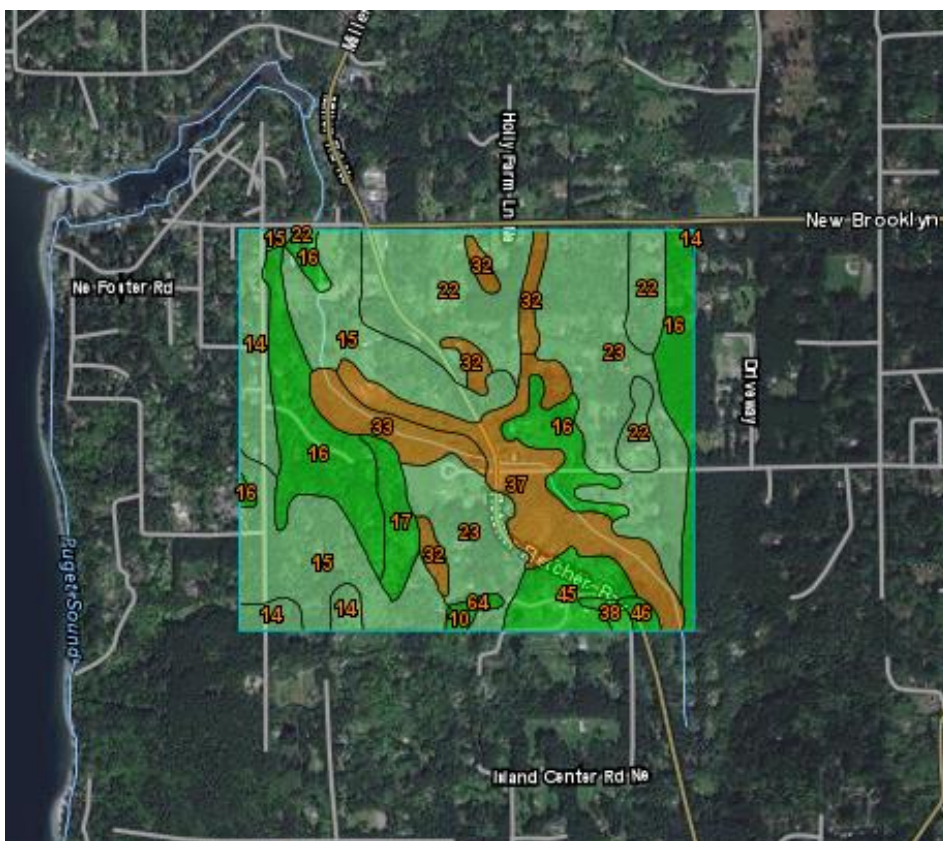
Figure 10 – This soil map shows the location of hydric soils (tan colors) in PAU 4. Map unit 33 is a peat soil, indicating conditions of constant soil saturation over the past 10K+ years. Map unit 32 & 37 are mineral based hydric soils, and are also saturated for long periods of time during the year. Taken together these hydric soil units are key areas for groundwater discharge and retention of surface waters. Source: NRCS web based soil maps

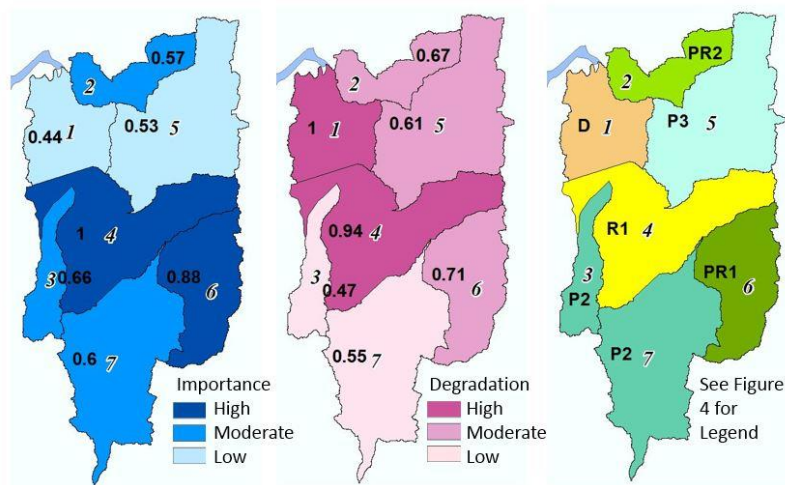
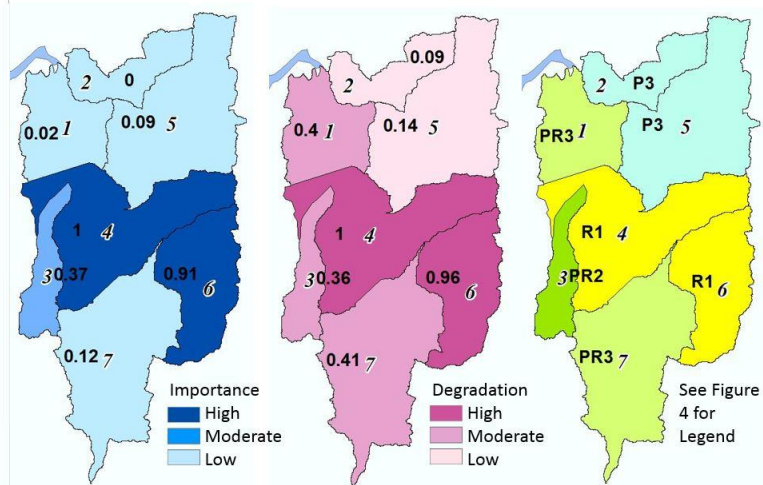
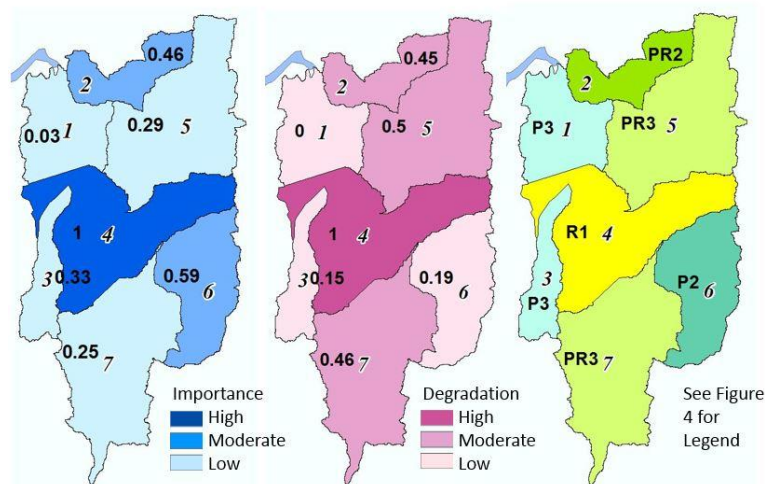
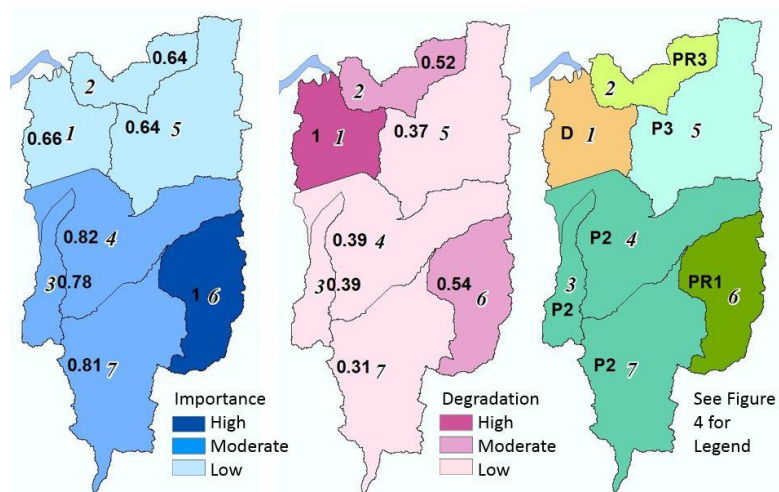
Figure 11. Bold" numbers from 0 to 1 are the normalized scores, with a higher score indicating a higher level of importance or alteration. The numbers 1 through 7 are the PAU or project assessment unit ID number. The blue basins represent the output of the importance model; the pink basins represent the output of the degradation model and the green/yellow basins represent combined output of the two previous models using the management matrix in Figure 4.

The results presented in Figure 11, provide a conceptual “snapshot” of how the water flow and sediment processes for the overall Springbrook watershed function together. A description and summary of this conceptual “snapshot” is as follows:

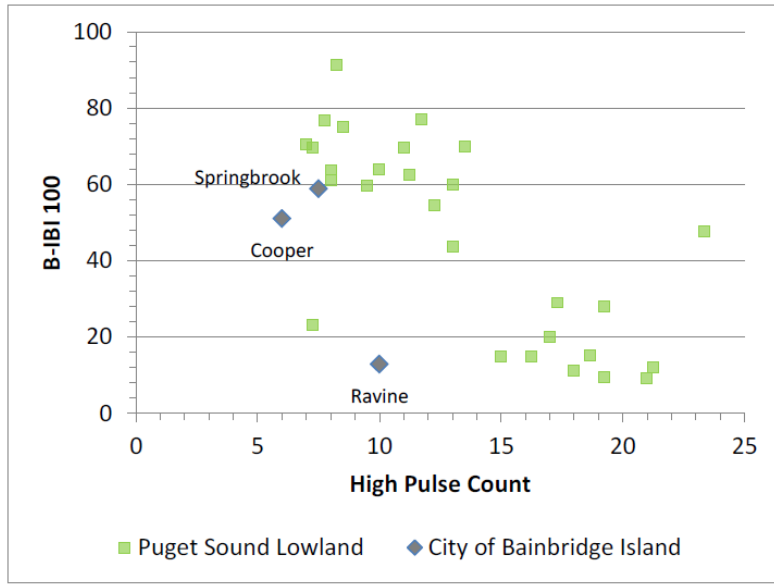
Figure 12. Comparison of the correlation of B-BIBI 100 and High Pulse data for Springbrook Creek watershed and WRIA 8 reference watersheds (green data points).
 Source: King County (DeGasperi 2015).

There are indications that fine sediment may be impacting the ecology of the Springbrook stream system. The City of Bainbridge Island funded a 2015 study by King County to evaluate stream benthos and hydrologic data for eight streams, including Springbrook Creek (2015 DeGasperi et al). The results show that while Springbrook Creek had a relatively low High Pulse Count (average of 8 per year), its Benthic Index of Biological Integrity (BIBI) scores were only fair. Streams with a lower High Pulse Counts are typically “healthier” hydrologically and biologically. Furthermore, Springbrook Creek appears to lie at the lower edge of BIBI data for WRIA 8 reference watersheds (Figure 12).

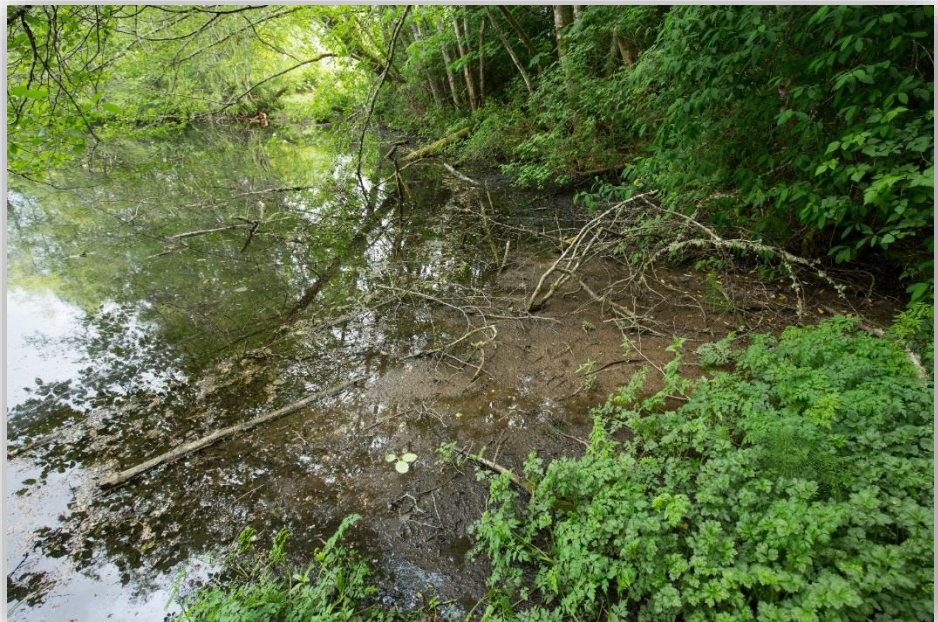
Figure 13. Fine sediment entering one of the upper ponds on the Johnson Farm property, assessment unit 7.

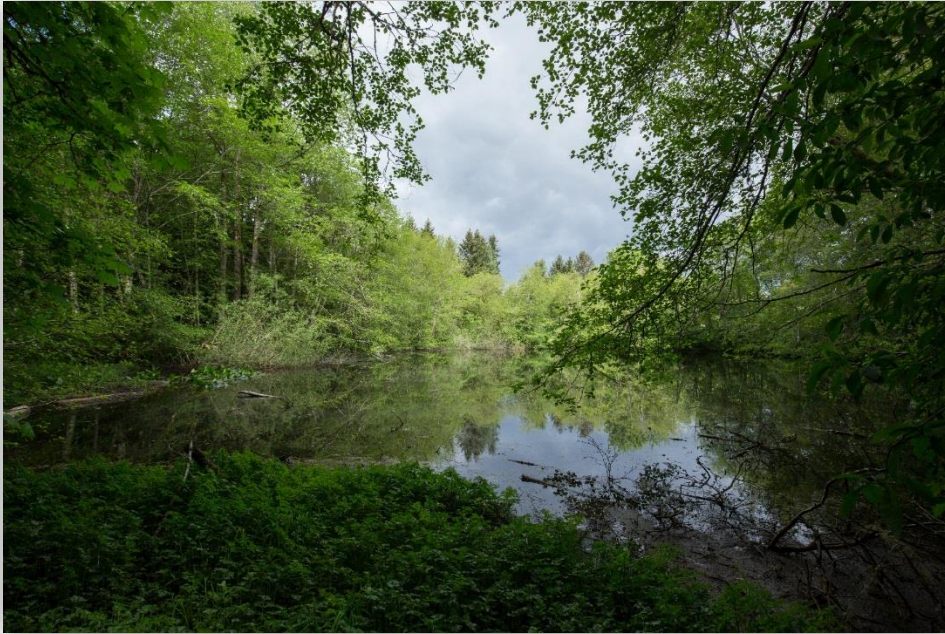
Figure 14. Upper agricultural pond on Johnson Farm, assessment unit 7. Note how the forested community shades most of the pond surface.

greater than that lost through evapotranspiration. It is possible that this type of loss can affect stream flows, particularly during low flow periods. It is recommended, therefore, that these ponds be allowed to fill in slowly and create a forested, scrub-shrub ecosystem that results in greater shading of pond waters (Figure 14).

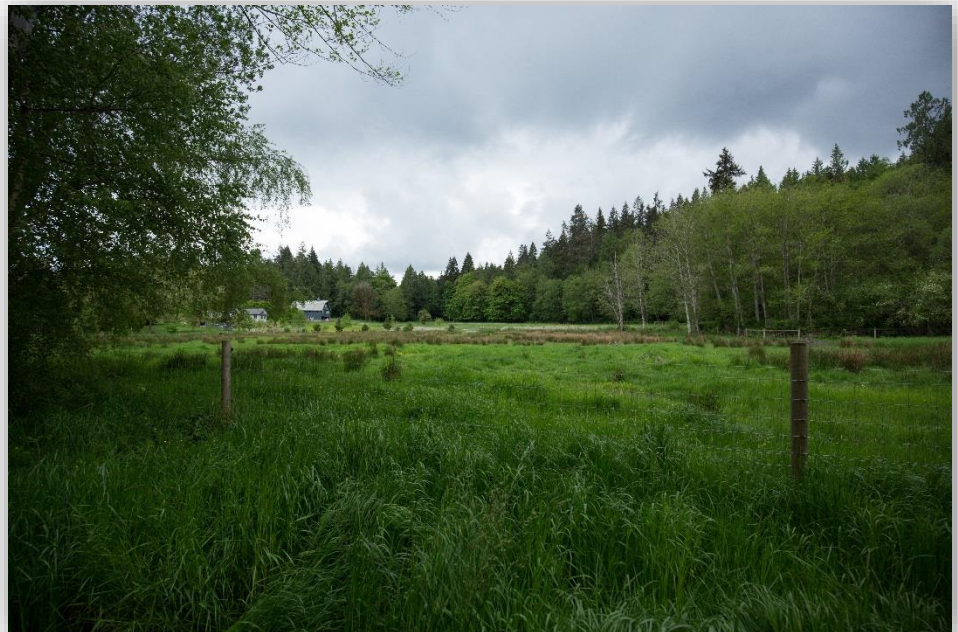
Figure 15. Example of conversion of depressional wetlands to pasture land in assessment unit 4. Hillside supports intact slope wetlands (Potential Project #7.5, Figure 8).

areas of historic forested depressional wetlands (Figure 15) into pasture lands. The creeks feeding into these systems have been channelized and flows moved to the edge of property lines away from the wetland complex. This has had the effect of partially draining these wetland systems, which has in turn changed their hydroperiod, allowing for the establishment and dominance by reed canary grass (Figures 15 & 16).

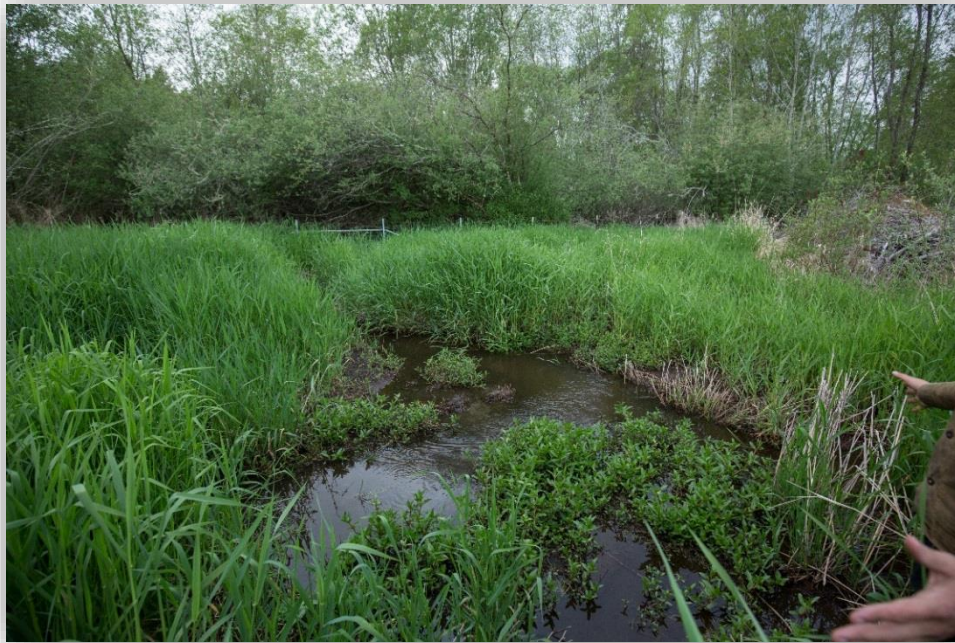
Figure 16. Channel being clogged by reed canary grass in assessment unit 4 depressional Wetland, Potential Project #4. This also results in filling of channel with sediment.

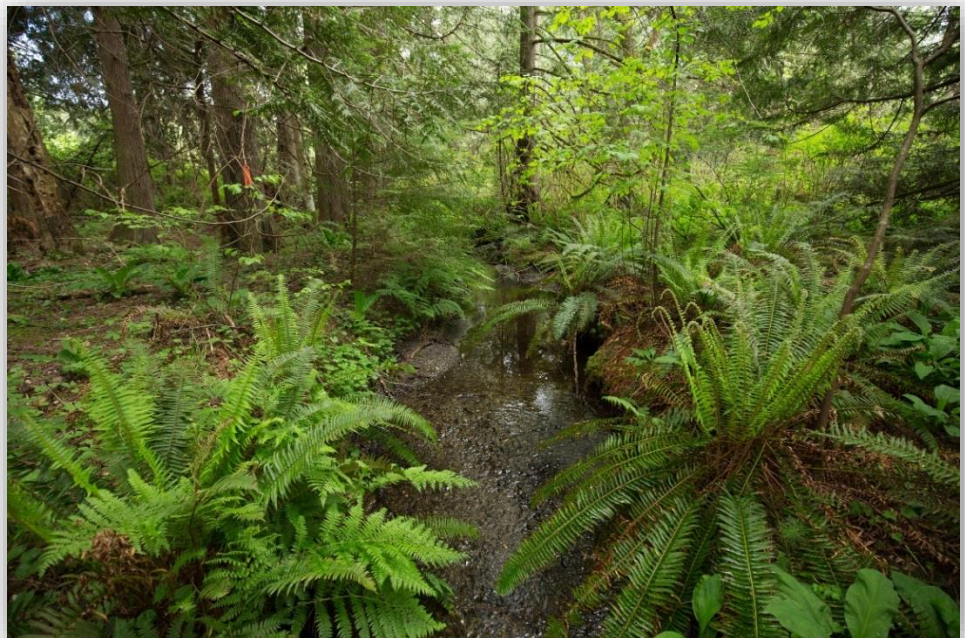
Figure 17. Example of properly functioning stream system similar to historic conditions, with forested canopy, scrub-shrub understory and sorted stream gravels without fine sediment impacts. Assessment unit 4, Potential Project #12.

Figure 18. Clearing of forested riparian vegetation (note wood piles) in floodplain of Potential Project #4, has resulted in alteration of floodplain processes. The resulting establishment of reed canary grass has altered stream flow path and decreased habitat diversity. Native forest cover provides for more diverse habitat structure and allows for the establishment of a clearly defined channel(s) as seen in Figure 17.

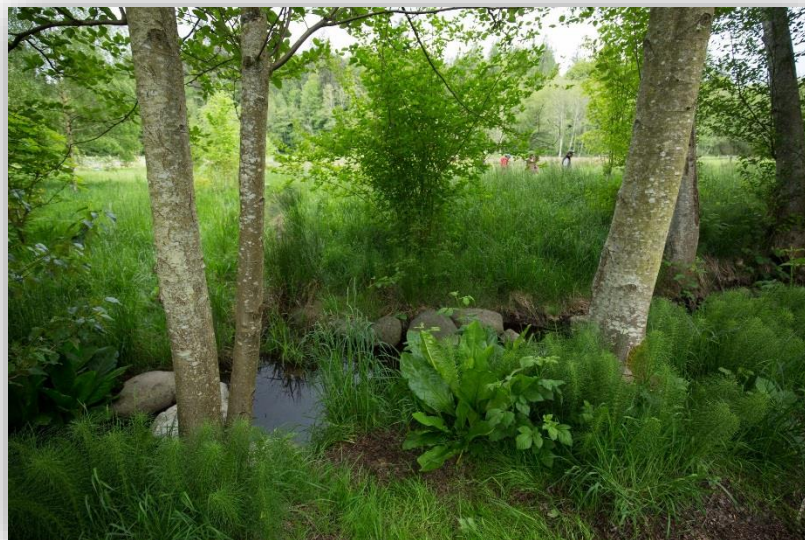
Figure 19. Example of measures to restore stream channel by fencing out livestock and replanting with a narrow forested buffer in assessment unit 4, Potential Project 7.5.

Efforts by landowners to restore watershed processes were evident throughout the watershed and included fencing off stream corridors and replanting buffers. This has the benefit of lowering stream water temperature through shading and eliminating reed canary grass which can completely choke the stream channel. These efforts should be continued with larger riparian buffers being created (Figure 19).

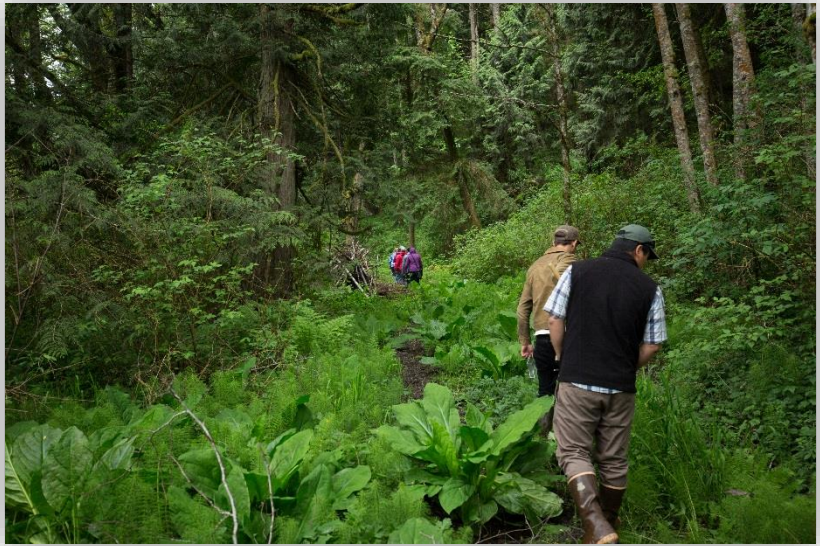
Figure 20. Forested, emergent slope wetland complex on the western boundary of Assessment Unit 4 (Potential Project #7.5). Note skunk cabbage, a wetland plant adapted to permanently saturated soils, in the foreground.

During the May 10, 2018 field survey, it was noted that extensive areas of seeps and slope wetlands were present on the slope defining the western boundary of the depressional wetland complex in assessment unit 4 (Figure 20). The presence of skunk cabbage suggests that this area is saturated throughout the year and as such plays an important role in supporting baseflows in Springbrook Creek. These intact forested slope wetlands should be protected through conservation easements.

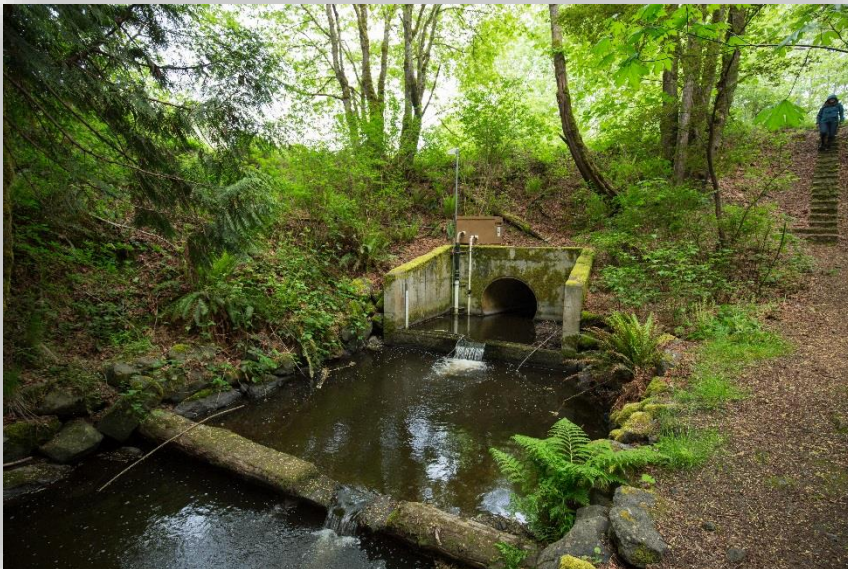
Figure 21. Culvert and weir system on Springbrook Creek just down stream of Fletcher Bay NE.

In assessment unit 1, as Springbrook Creek descends to meet its tidal channel and Fletcher Bay it passes through a culvert under Fletcher Bay NE and through a series of downstream weirs (Figure 21). This system was engineered to create an artificial stream gradient that met the elevation of the road culvert. The weir system, however, is beginning to fail, due to natural stream processes, which could result in the washing out of the weirs, headcutting and

isolation of the culvert from the downstream streambed. This would make the upper watershed inaccessible to anadromous fish.

To avoid this, the existing culvert and weir system should eventually be replaced, with a larger bioengineered bottomless culvert that re-establishes the historic grade of the stream and eliminates the need for a “stepped” weir system.
