### **Project 4 Stream and Riparian Restoration Project**

#### **Conceptual Design**

**Project 4 Stream and Riparian Restoration**  
**Kitsap County Tax Parcel 202502-4-050-2002**

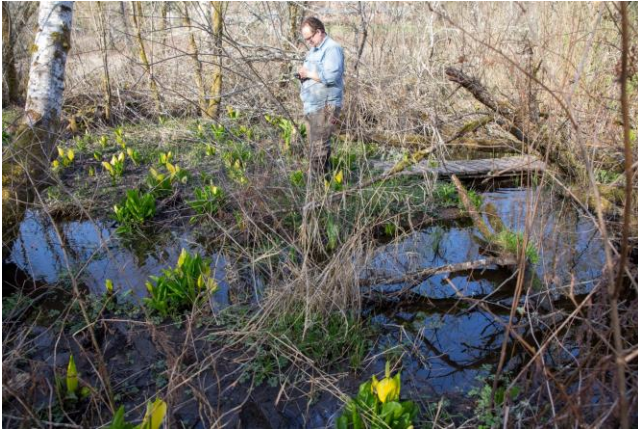
Photo 1: Looking south main avulsion in stream – to the right the historical stream channel leads to the meadow which has been cleared.

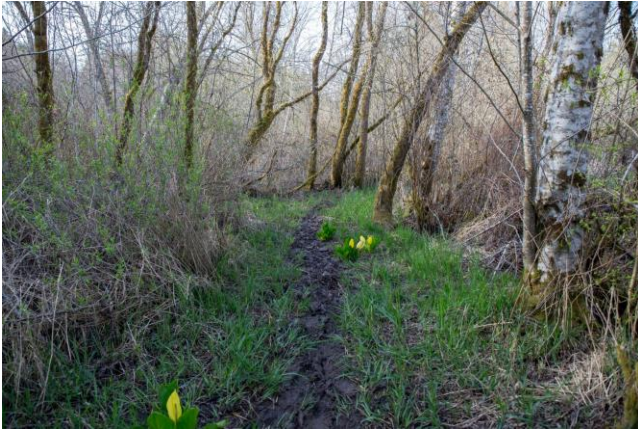
Photo 2: Existing pathway and area for stream within riparian area.

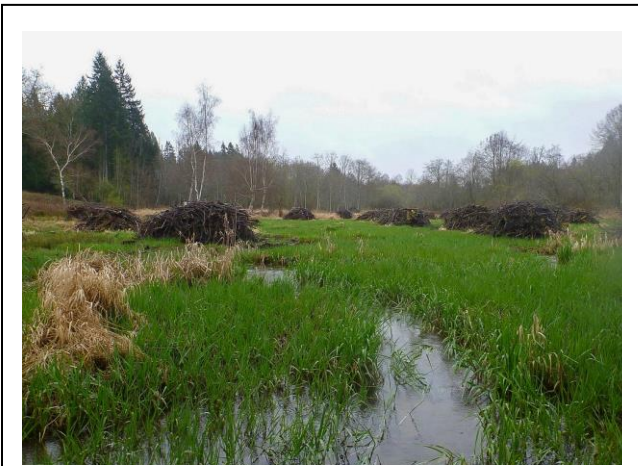
Photo 3: Stream within meadow choked with reed canary grass and lack of riparian cover.

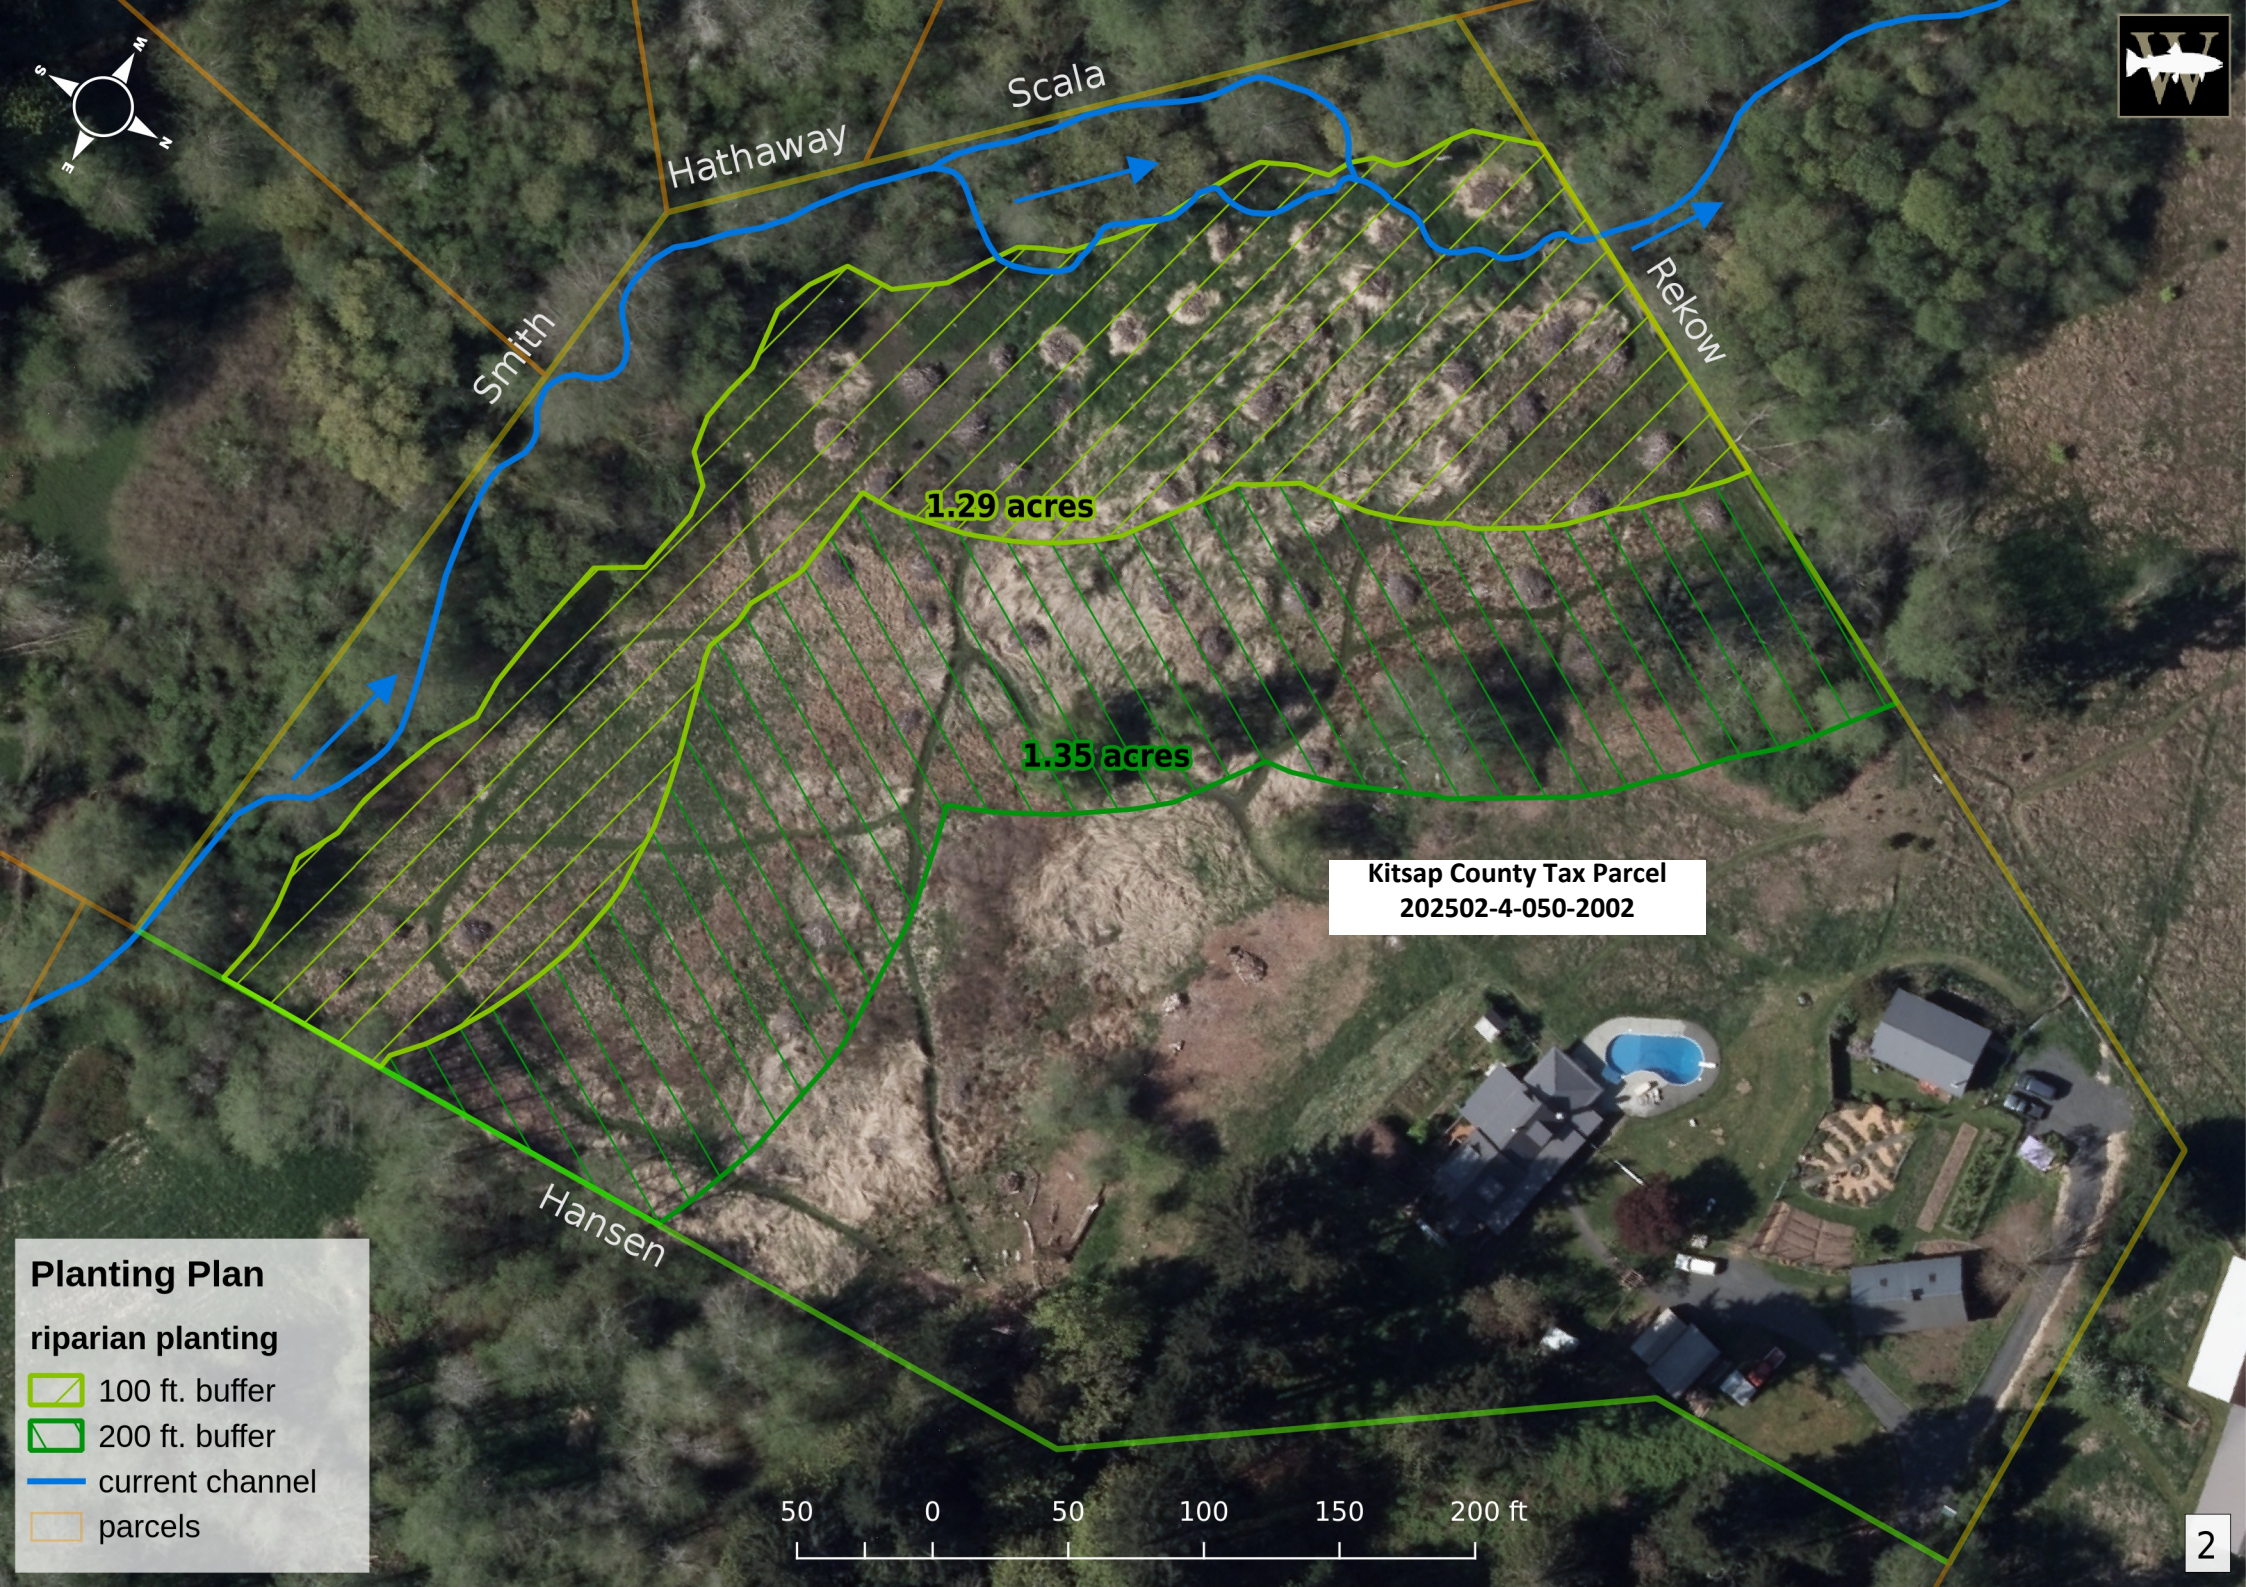
**Planting Plan**

**riparian planting**

100 ft. buffer
-

200 ft. buffer
-

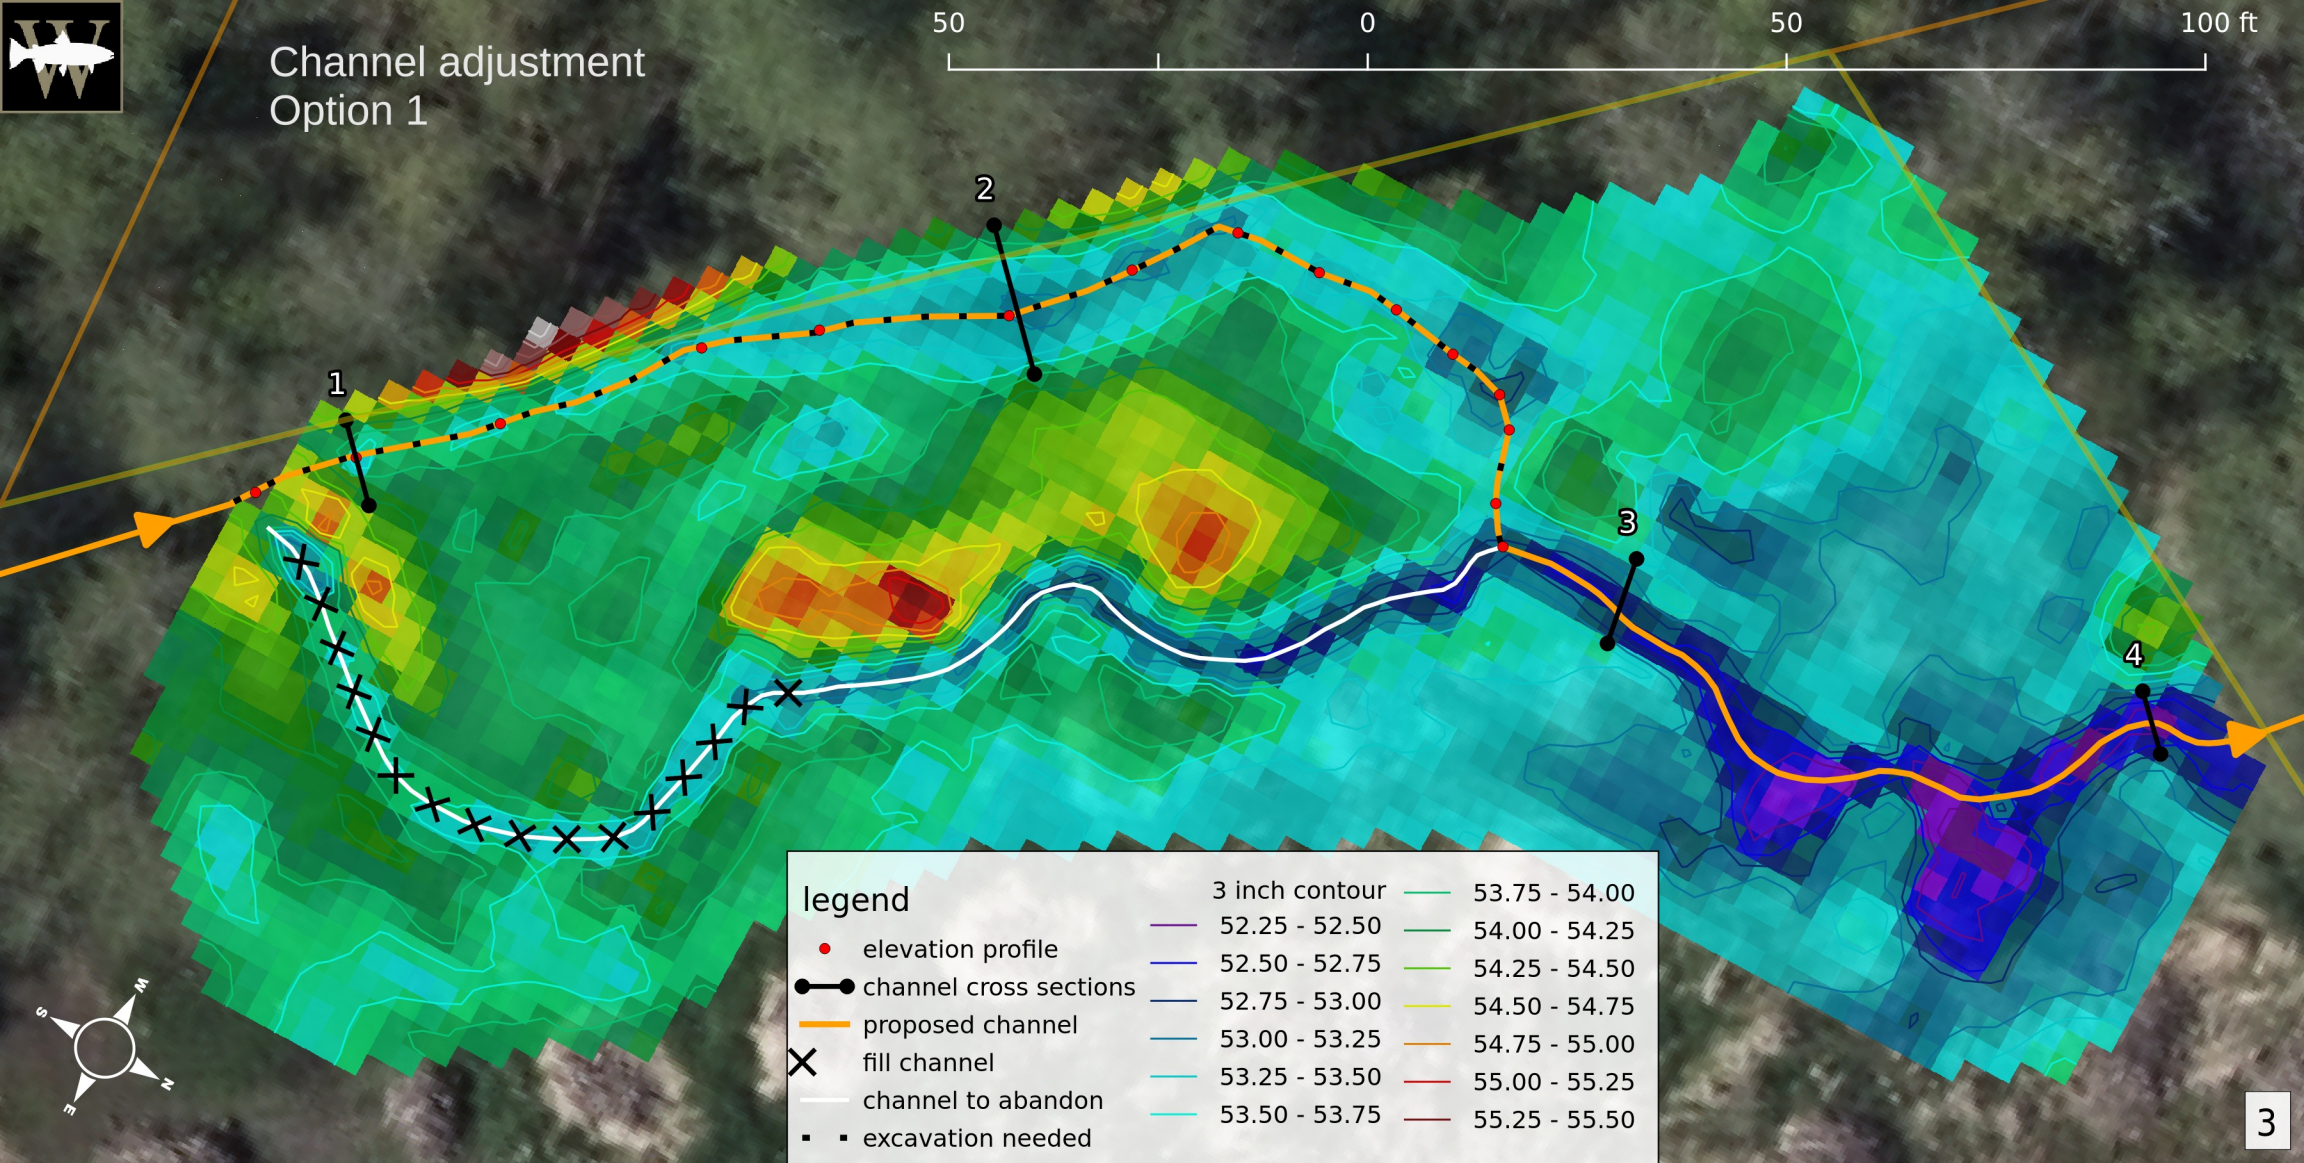
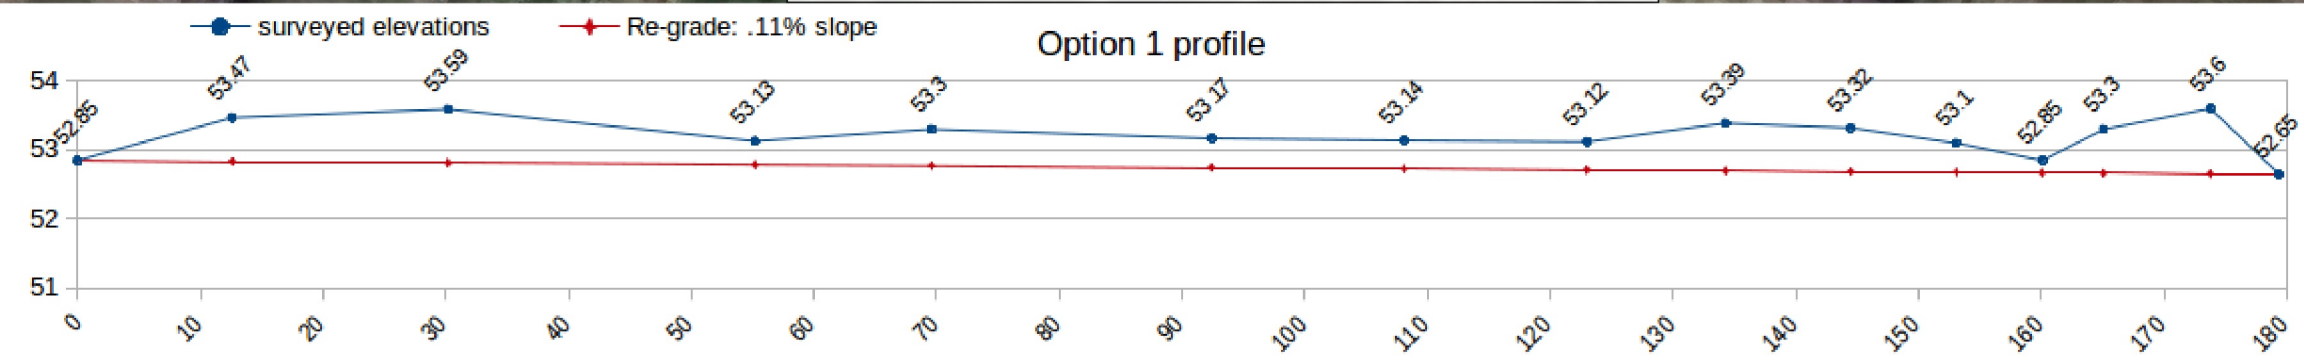
Option 1 is a two tiered approach to address the section of channel now choked by the recently established reed canarygrass. At the existing avulsion we propose to plug the main channel with woody debris and wood cuttings, and with minor (hand equipment) excavation to encourage all flows to pass into the forested left bank avulsion channel. The exact geometry and course of the forested left bank avulsion channel will be determined during the final design and permitting process. The plugging of the main channel using existing woody debris to force the avulsion, and the amount of excavation in the avulsed channel would be the minimal needed to encourage summer flows in to the avulsed channel. Downstream from the plug, the right bank channel would be flooded from the downstream direction (backwatered) providing seasonal off channel habitat during times of high flow. During storm events, the plugged main channel would still function to accommodate and convey high flows. Throughout the valley floor we propose an aggressive planting regime of native trees and shrubs to mimic the well-established stand of shrubs adjacent to the cleared area.

The project team and the landowner preferred the conceptual channel modifications described in Option 1 in order to route summer low-flows through the existing forest for a longer distance than currently occurs. All agreed that Option 1 provided similar ecological benefit but at reduced cost and with fewer unintended impacts to the landscape compared to Option 2. The landowners deliberated riparian options at length and in the end decided they were more comfortable with a 100 foot buffer (1.29 acre) riparian planting rather than a larger one as they prefer to maintain some of the meadow / pasture habitat to which they are accustomed. The landowners are also interested in maintaining the existing simple footpath network through the meadow, wetland, and riparian areas in a way that minimizes riparian impacts and aid in plant maintenance activities. The footpath details would be determined in the final designs, with the input from permitting agencies.

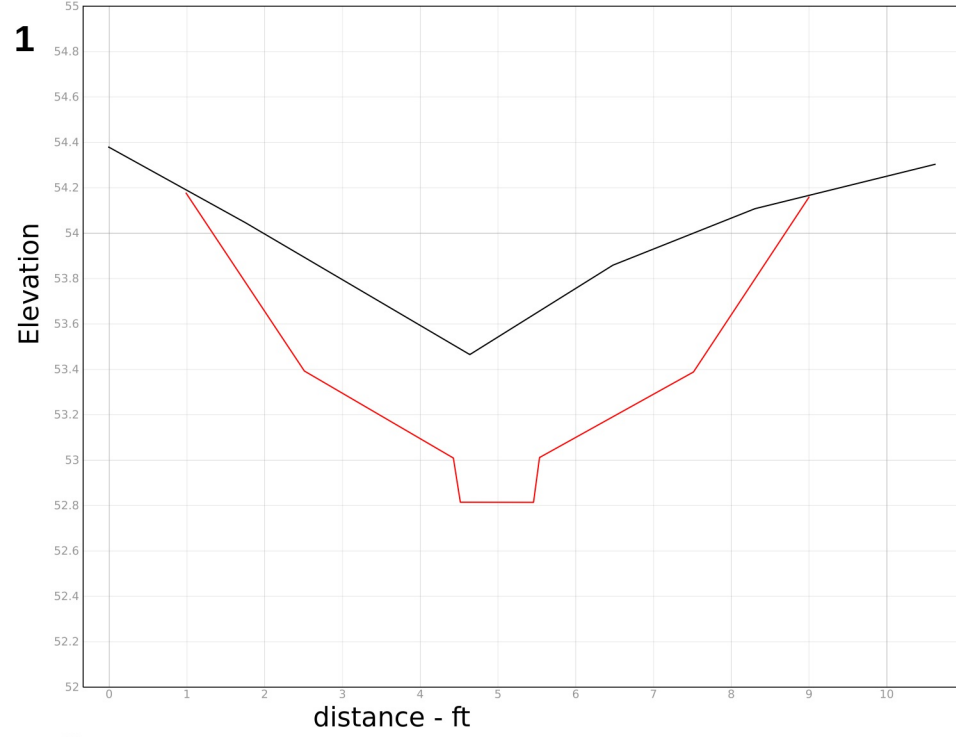
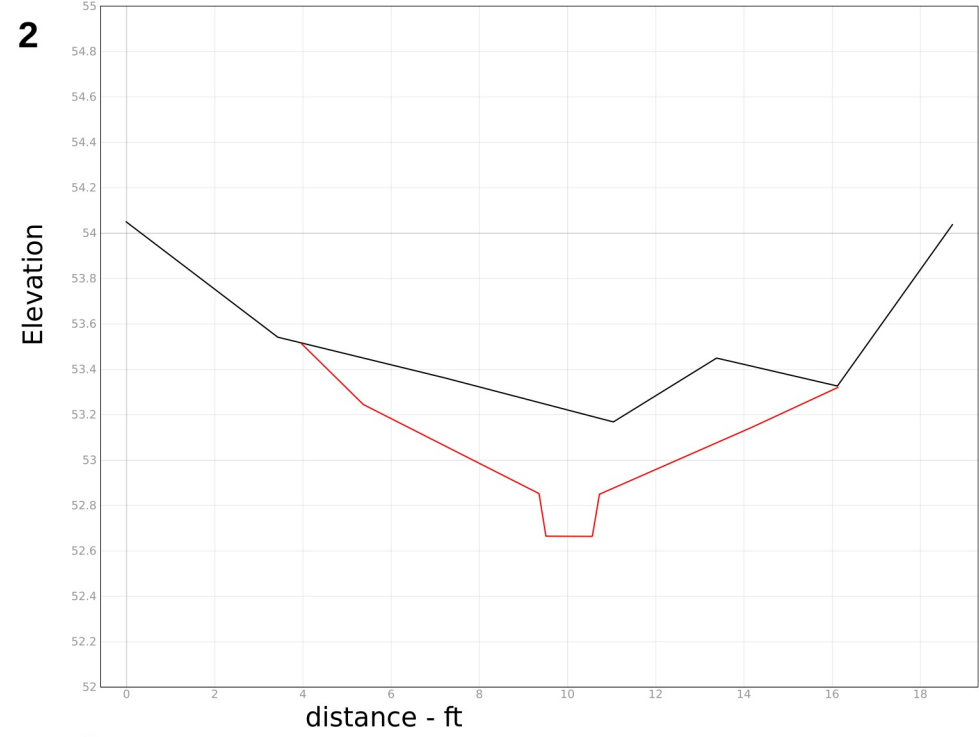
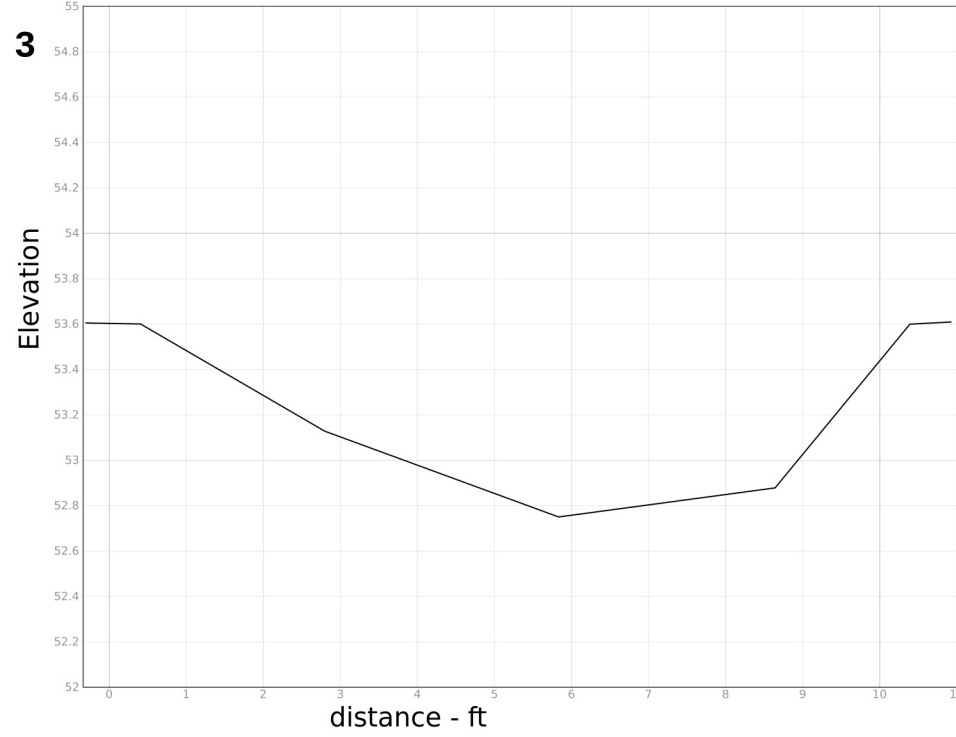
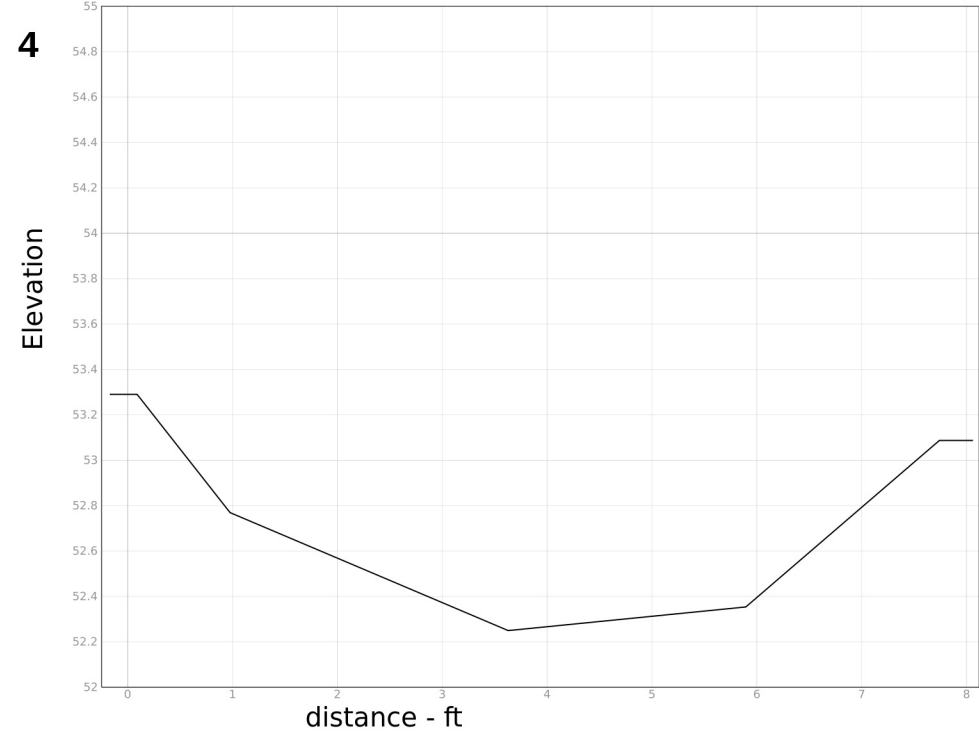
# Option 1 channel cross

— ground profile — design profile

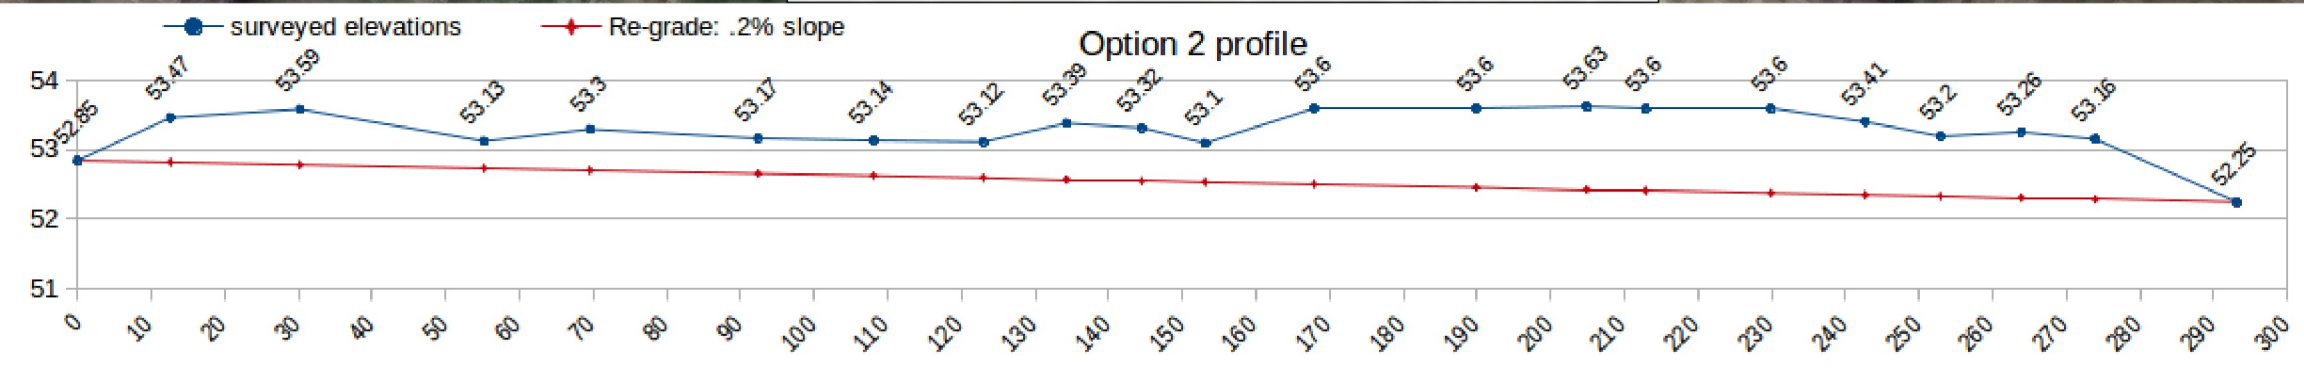
# Channel adjustment Option 2

Option 2 is similar to Option 1, but with more extensive excavation. As in Option 1, in this approach we propose to plug the main channel with willow cuttings and woody debris, and utilize the 150 ft. of the avulsed channel through the forested wetland. However, we propose to then maintain flows in the forested wetland for a longer distance rather than return flows to the main channel through the natural course (into the reed canary grass monoculture). A 60 ft. long channel would be hand excavated at the northern edge of the forested wetland. At the property line, the new channel would turn north east and follow the fence line through the open field to the established stream corridor off of the property.

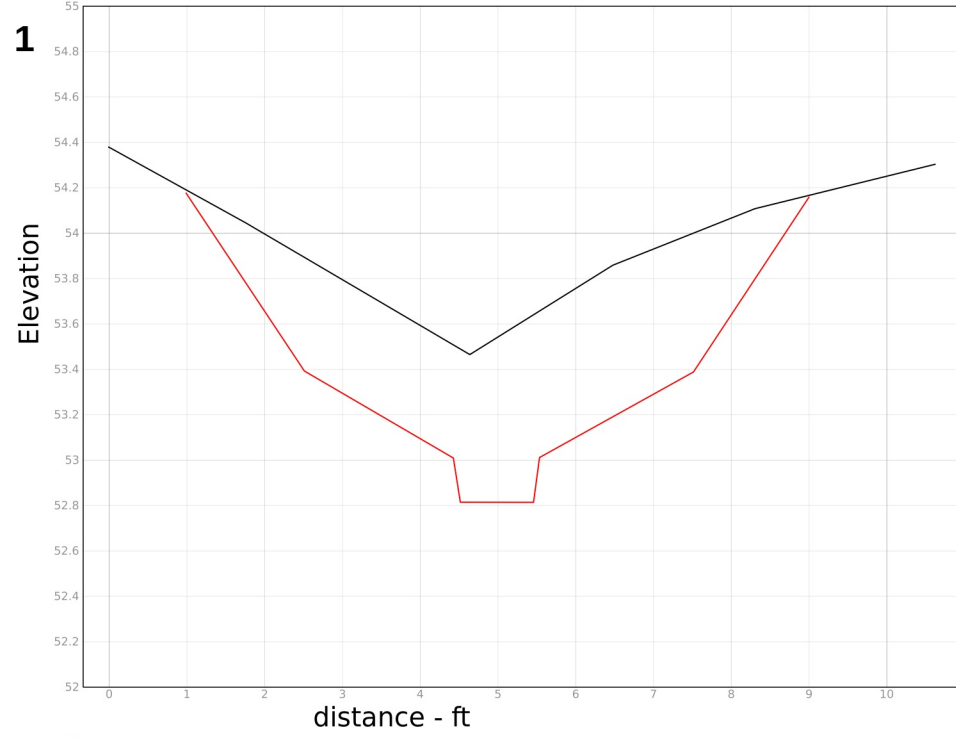
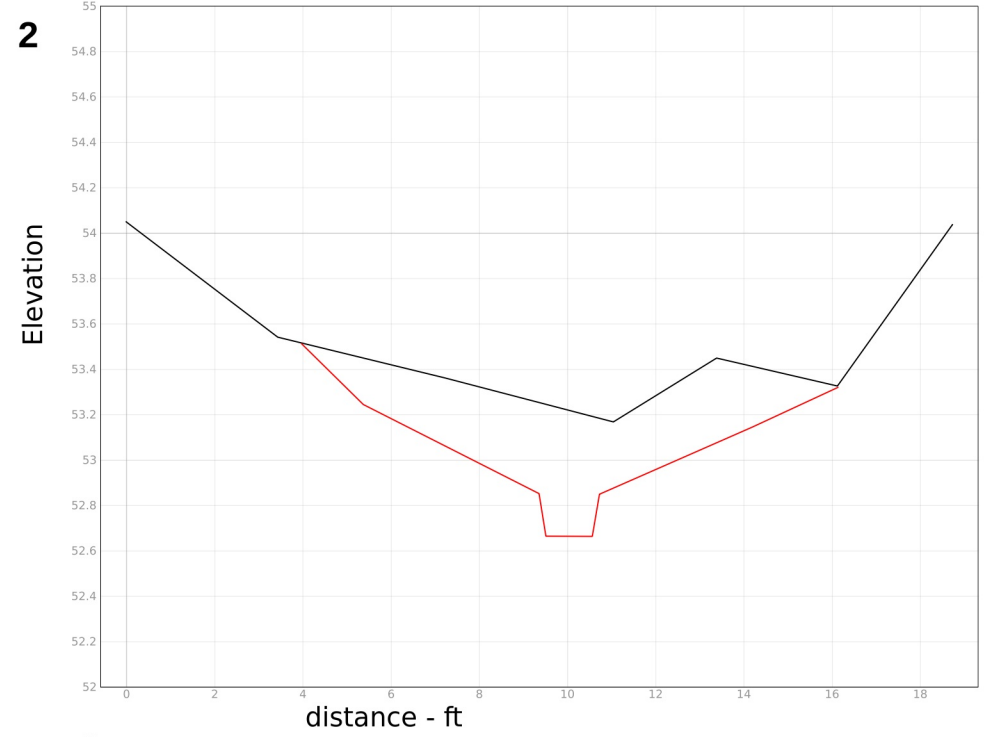
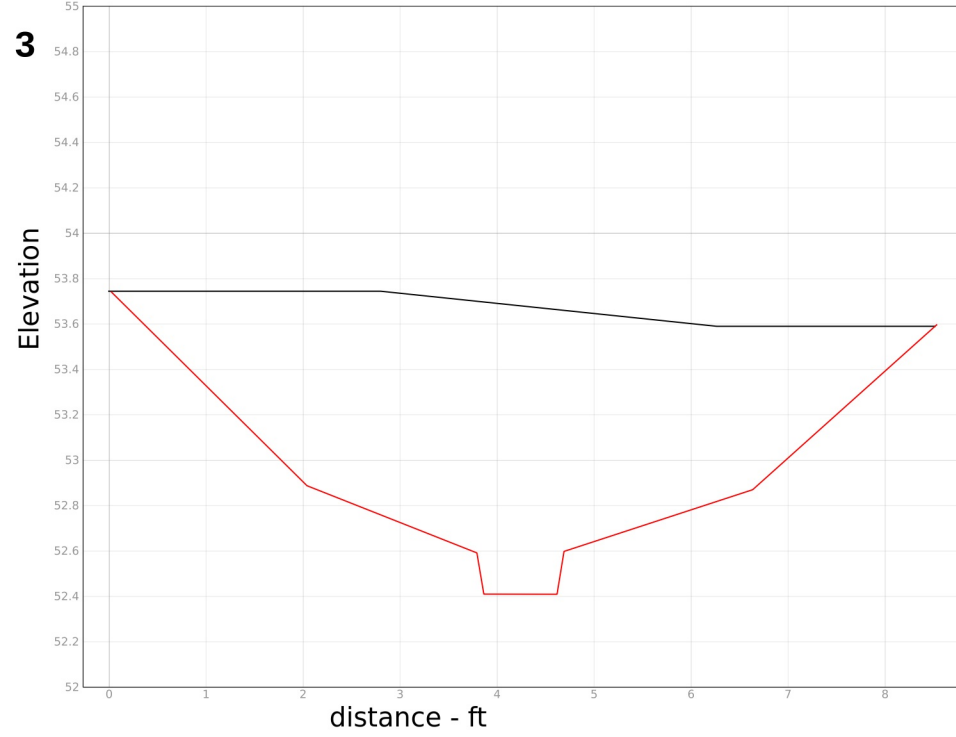
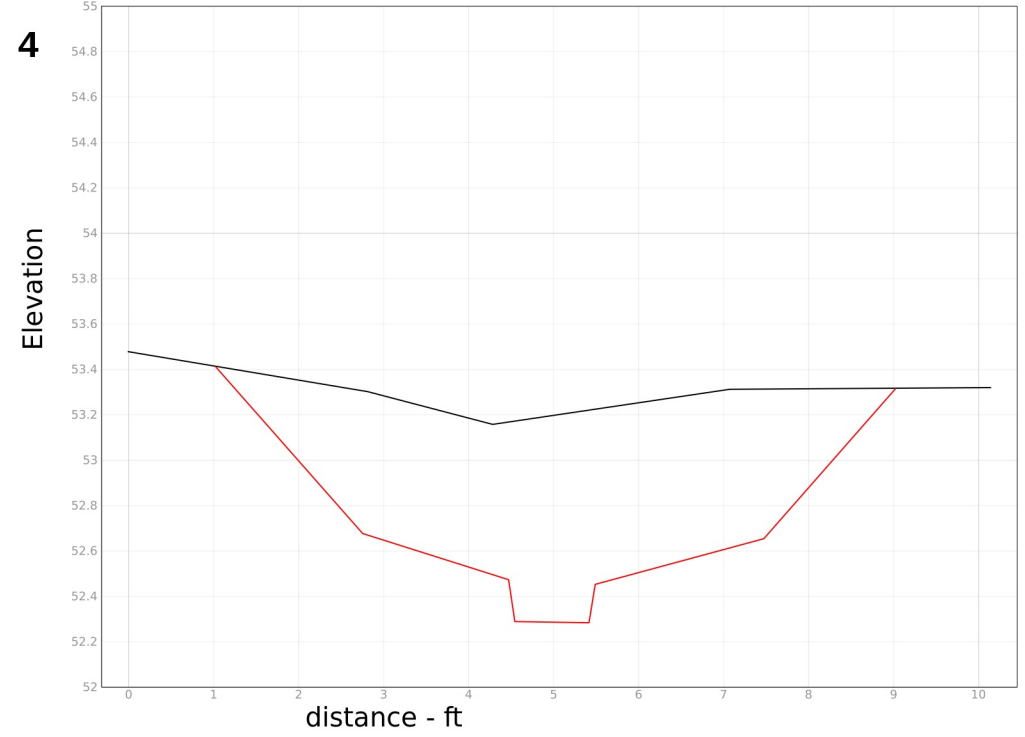
# Option 2 channel cross

— ground profile — design profile
