Powel Shoreline Restoration Design Project

Project # 09-1691N • Final Report • May 2011

Powel Shoreline Restoration Design Project
Project # 09-1691N
Final Report
May 20, 2011

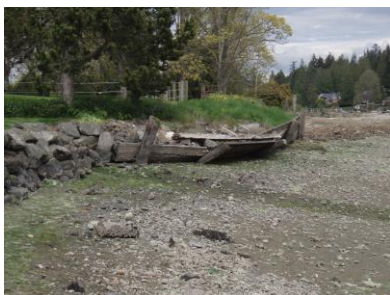
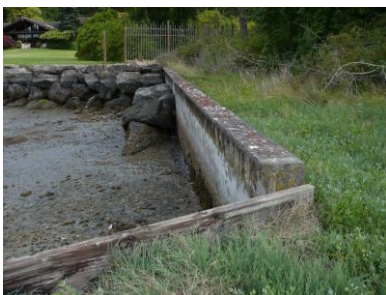
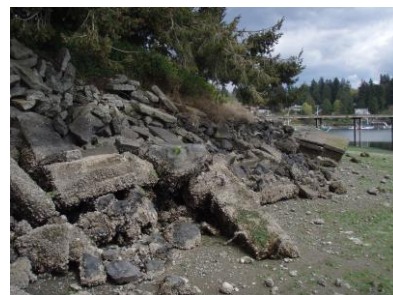
Examples of existing armor on the Powel property. Under the restoration design, the armor in these areas would be removed.

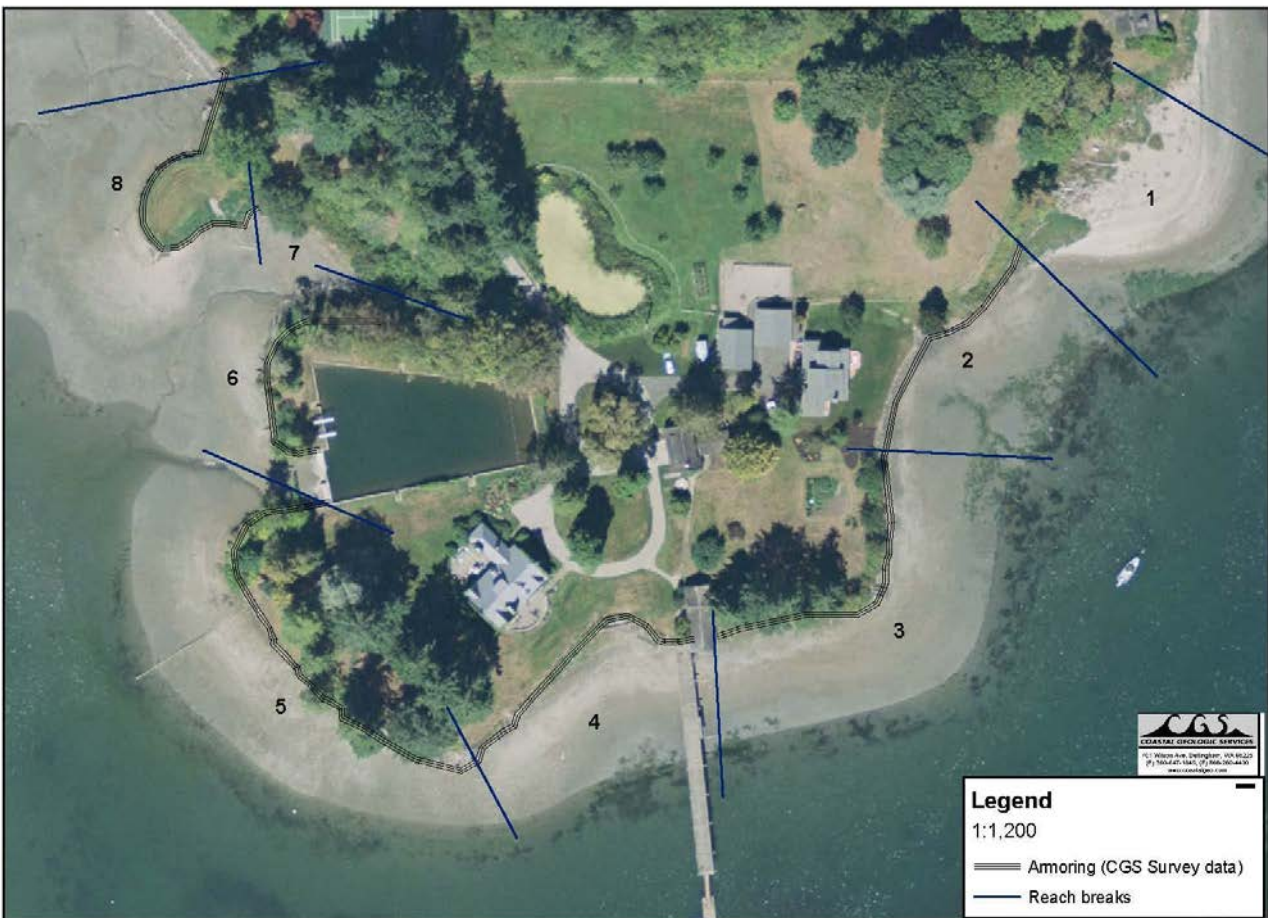
Figure 7. Powel property shoreline reaches and armoring.

The approximately 1,890 feet of shoreline encompassed within the Powel property was divided into eight shore reaches of unique character, for which restoration alternatives were evaluated to arrive at a preferred alternative. The reaches are numbered from northeast to northwest (Figure 7). Reach and structure characteristics are displayed in Table 9.

With information that included a site map, site conditions, reach characteristics and a primary list of restoration opportunities and constraints within each reach, the stakeholder group met eight times during a 12-month period to review various drafts of the design and specific design details, ask questions, recommend revisions and resolve differences in preferences for alternative restoration actions, including no action or limits on proposed actions. Additionally, the project manager communicated with stakeholders by email and telephone during the entire project period to provide additional information, clarification, meeting materials and work products for review and to address any outstanding questions or concerns raised by stakeholders. Major design discussions and decisions were captured in meeting notes and are summarized in the summary decision matrix (Table 19) in the form of a brief narrative description of the major topics discussed regarding each reach. The reaches are delineated on the site map (Figure 7).
