A GROUNDBREAKING SHORELINE RESTORATION " PUGET SOUND

A groundbreaking shoreline restoration on Puget Sound (2013) Washington Sea Grant WSG-AS 13-03. Brochure PDF: wsg.washington.edu/ powelbrochure

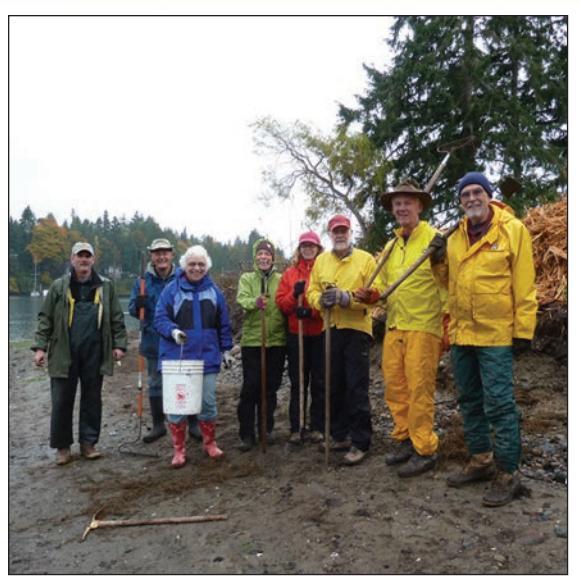
Volunteers helped transplant pickleweed (*Salicornia* sp.) — an important native intertidal plant. Monitoring will help determine if this experimental treatment was effective.

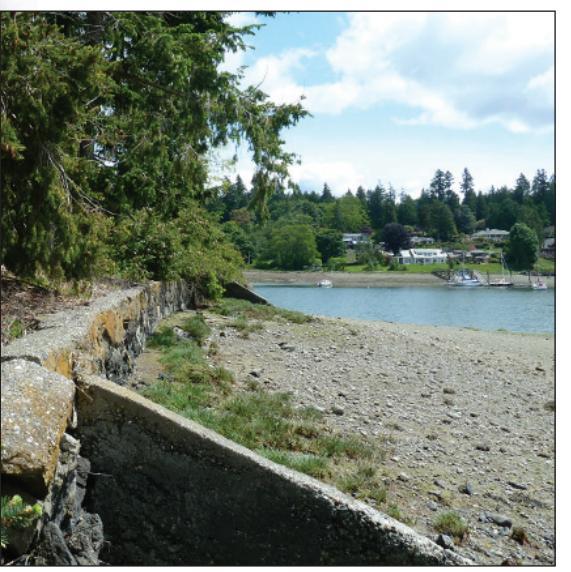
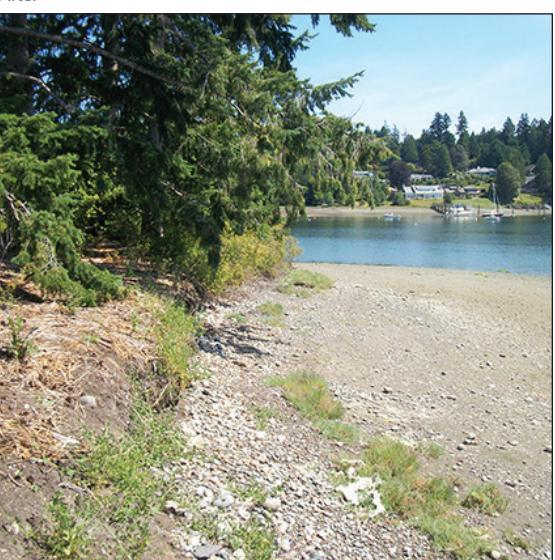
After

The photos above and at the top of the next page illustrate before and after armor removal. Armor and fill materials were removed with very little engineered reshaping of the slope. The restoration design emphasized the concept of letting nature reshape the shoreline.

ver 1,500 lineal feet of shore armor were removed along with associated fill, resulting in a 163 percent increase in intertidal area and salt marsh; 33,000 square feet of riparian area were cleared • of invasive plants and replanted with native vegetation; existing infrastructure remains protected. This was all done within the predicted budget and timeframe. Shoreline restoration on private residential property is critical for achieving Puget Sound salmon recovery goals and restoring shoreline ecological functions. In order to engage private landowners in these efforts, it is important to combine restoration actions that are compatible with residential living. To replace the bulkhead would have cost approximately \$300 per foot, plus the cost of debris removal and disposal, for an estimated cost of \$512,000. At this site, restoration was not only less expensive, but provided many ecological benefits, for which it is difficult to assign a dollar value but which will pay dividends in perpetuity. The result is a more resilient, ecologically functioning shoreline that is aesthetically pleasing to the landowners and neighbors.
