HABITAT RESTORATION: BAINBRIDGE ISLAND NEARSHORE

Suggested citation: Adams, J., B. Padgham, J. Toft. 2015. Habitat Restoration: Bainbridge Island Nearshore. Puget Sound Partnership, Tacoma, WA. <u>http://www.psp.wa.gov/effectiveaction.php</u>.

PROJECT SUMMARY

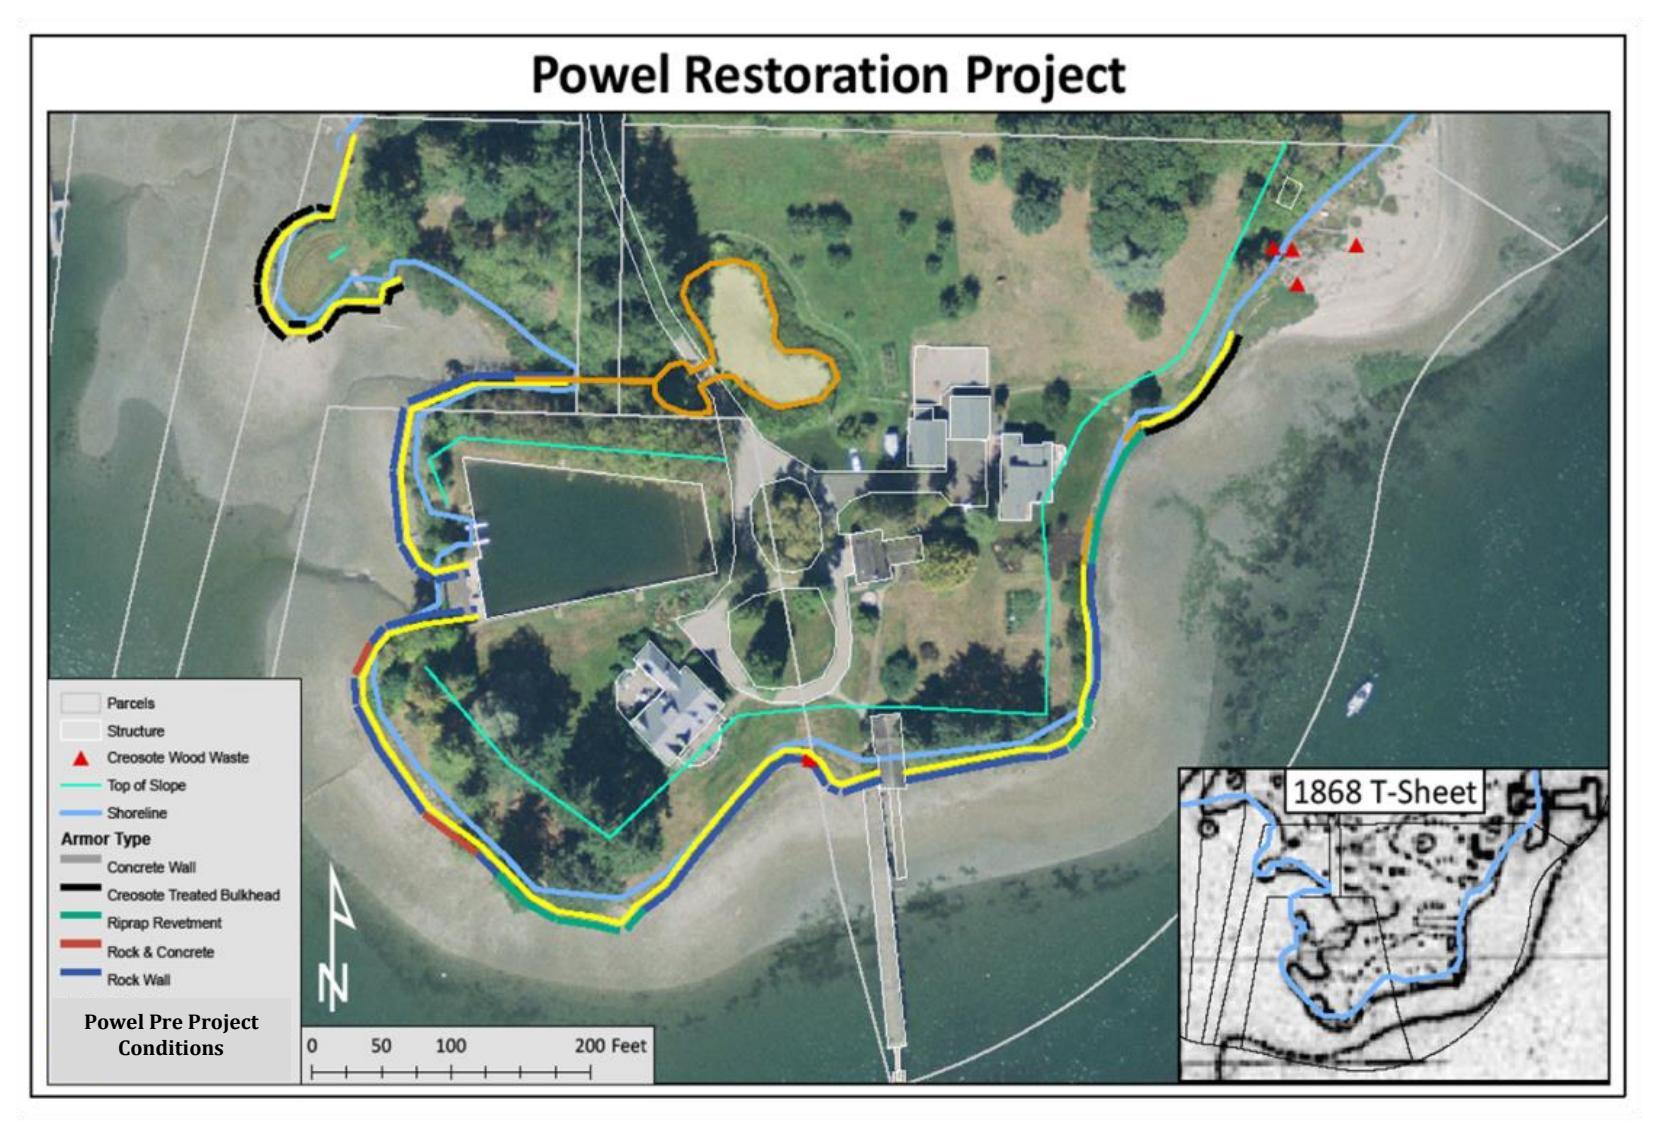
Figure 2. Pre-restoration project conditions at Powel property showing different types of armor.

The Powel Restoration Project was planned, designed, and implemented to restore marine shoreline on private residential property. The Powel property includes two parcels, nearly 11.8 acres of tideland, nearshore and upland property and more than a third of a mile of marine shoreline. With the exception of two small shoreline segments, the entire 1800 linear feet of shoreline was armored with a variety of structures, including rock rip rap revetments, creosote timber walls, rock and mortar walls, concrete walls, and concrete debris (Figure 2). Much of the armor was aged and in a state of disrepair (Figure 3).

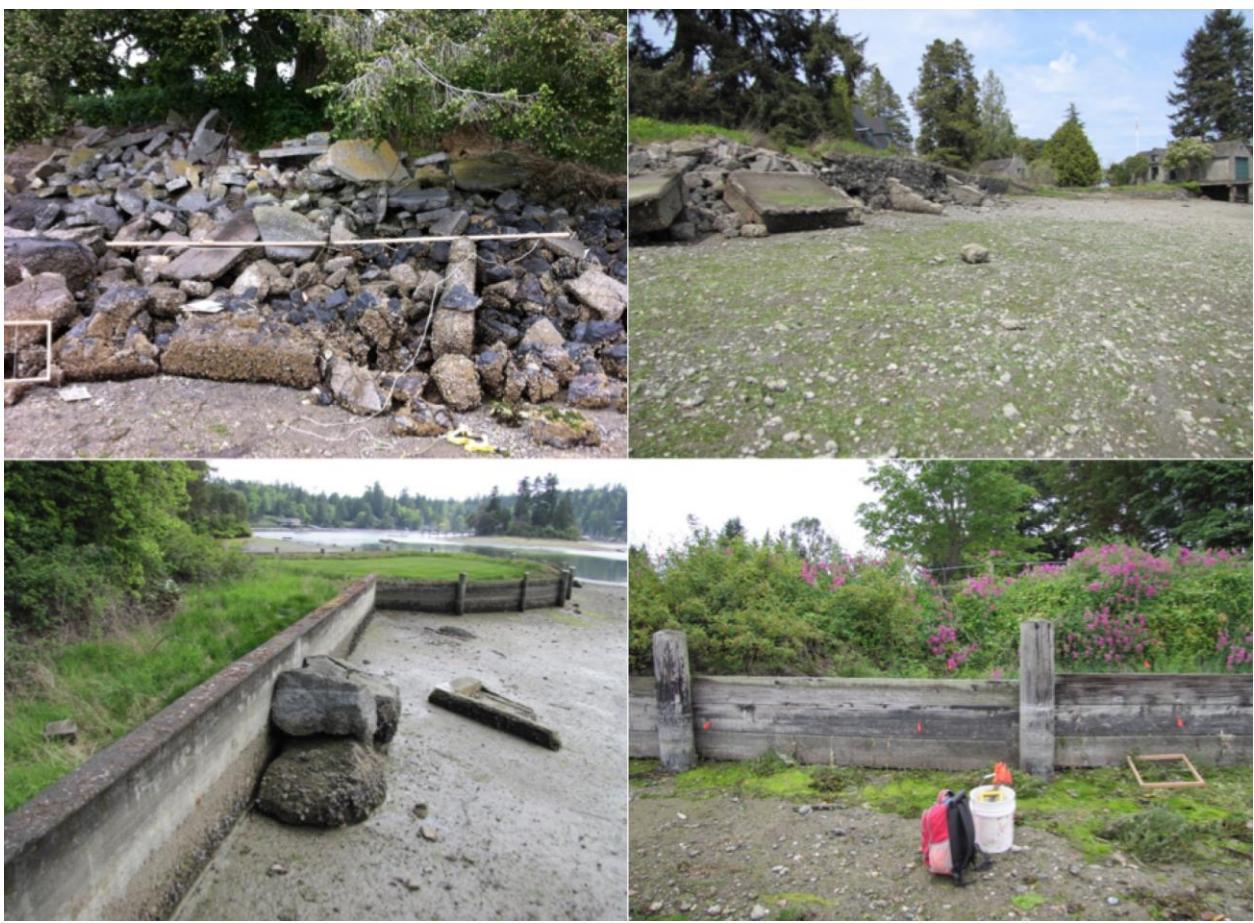
Figures 3. Examples of armoring at the Powel property before removal.

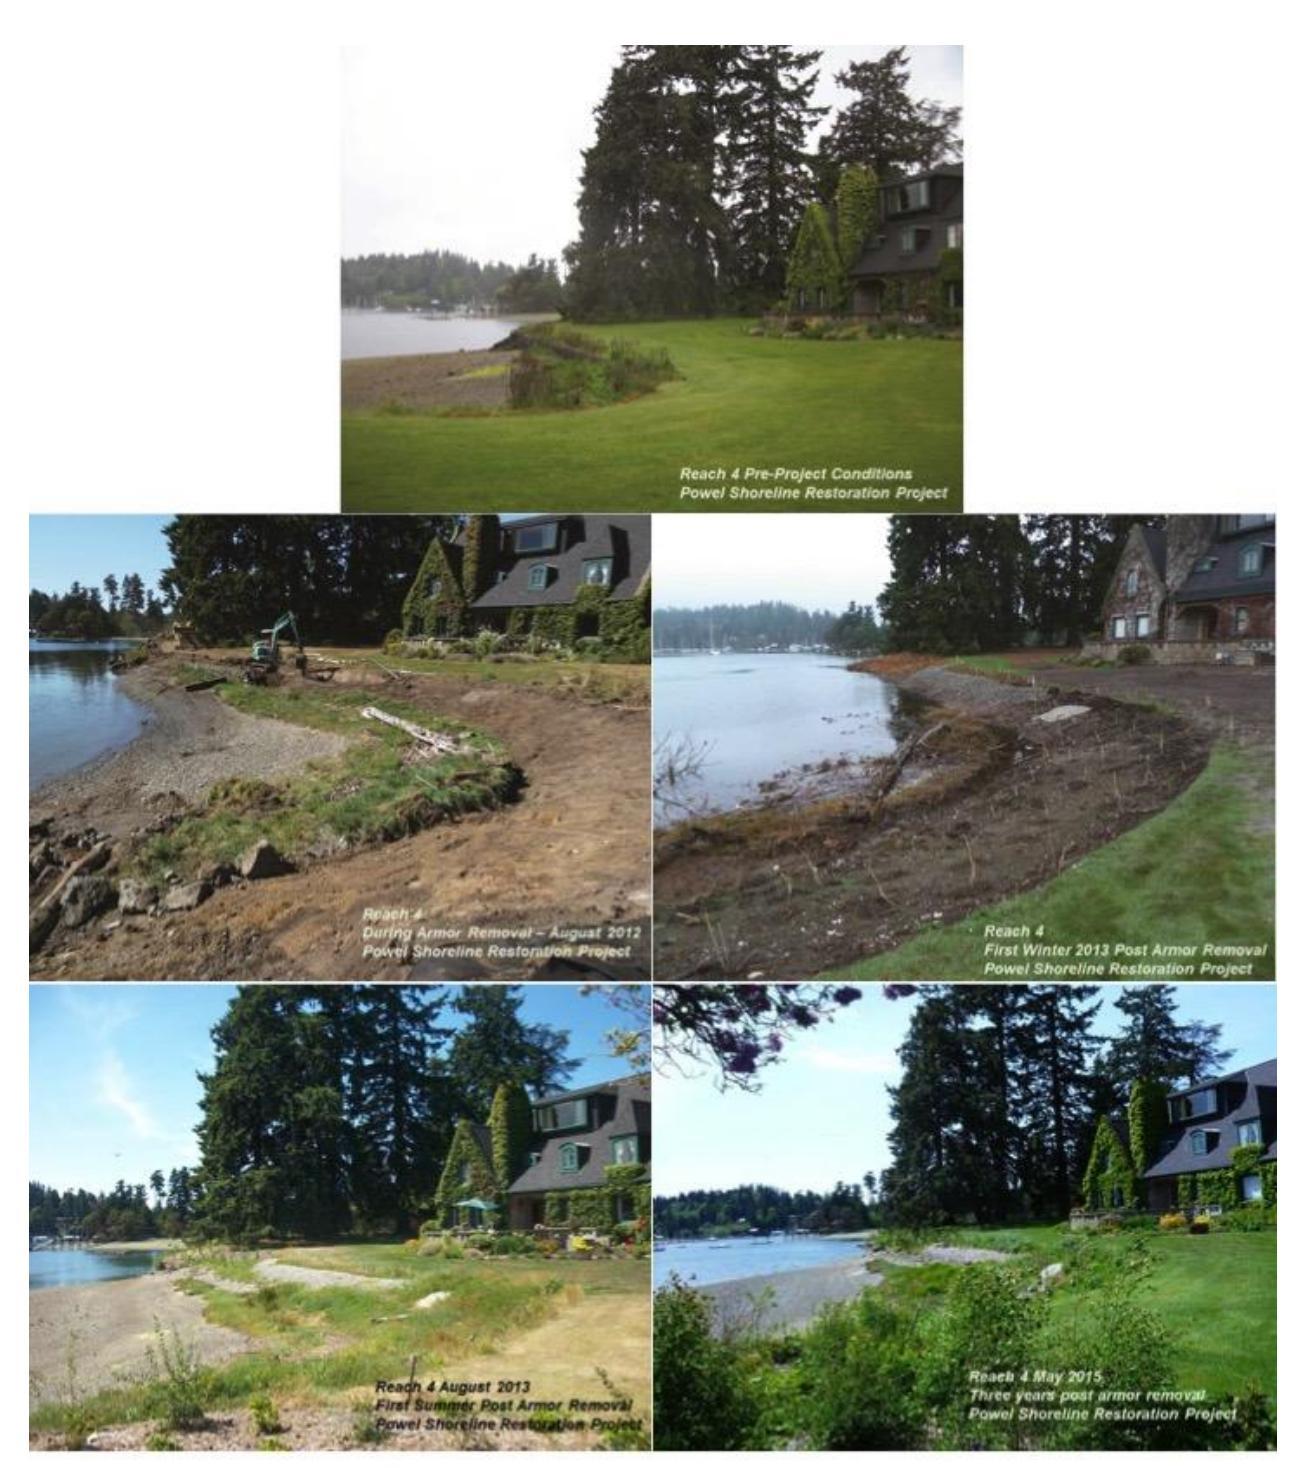
Figure 4. Photo monitoring of Reach 4 before, during, and up to 2.5 years after bulkhead removal illustrates the enhancement of salt marsh and riparian vegetation. While salt marsh vegetation was present at the base of the bulkhead prior to restoration, the removal of the bulkhead allows vegetation to spread and naturally transition into the riparian area, and vice versa.

• Native riparian vegetation and riparian ecological function and connection had been lost as a result of shoreline development. These connections were restored as barriers were removed and salt marsh and upland vegetation allowed to expand. Photo documentation clearly shows changes in site characteristics and vegetation development (Figure 4).

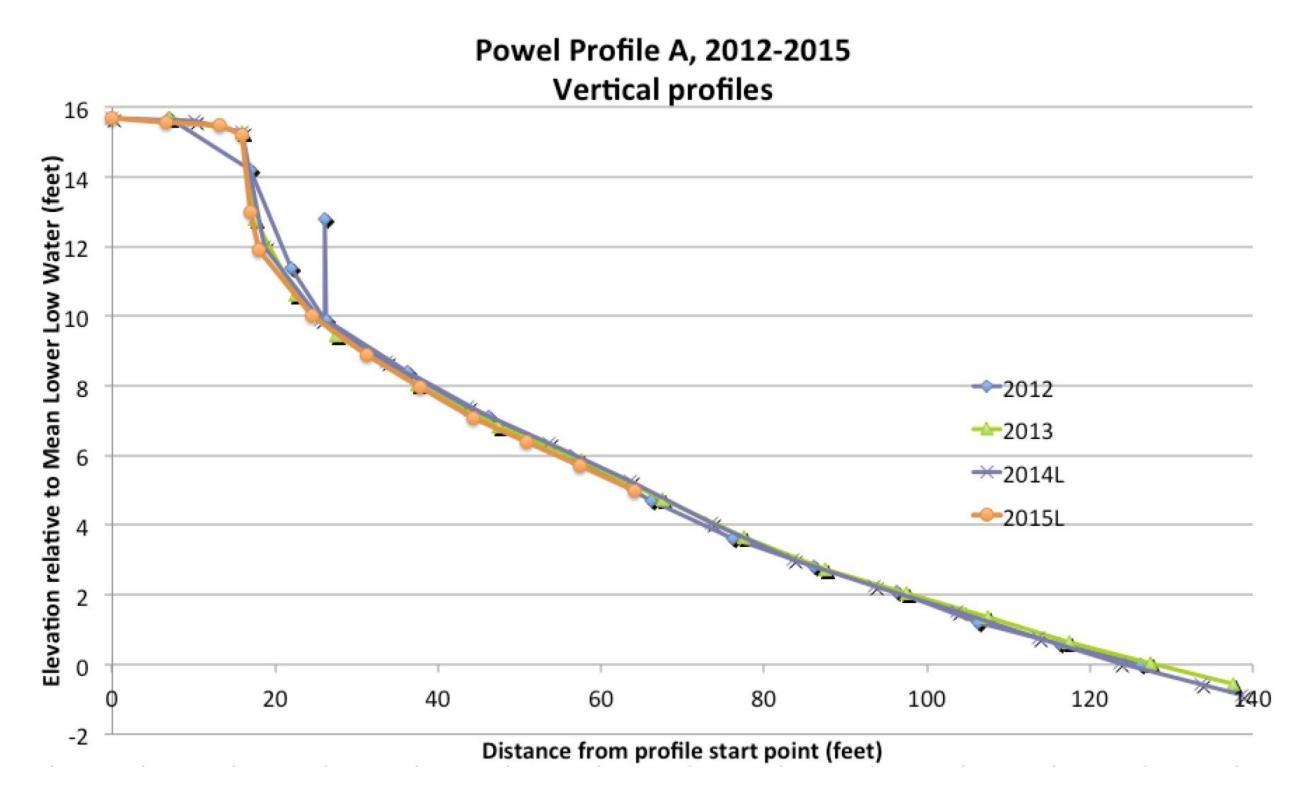
Figure 5. Adjusted vertical profile measurements taken annually along Powel Profile A show that the beach slope has not changed significantly and that erosion at the bluff to date is happening slowly. The 2012 and 2013 profile start points have been adjusted because they were located based on triangulation. A permanent marker was established in 2014 providing greater consistency from that time forward.

- One of the goals of bulkhead removal is to allow for sediment to naturally deposit onto beaches. Monitoring profiles of the property took place from the low tide to the high tide (See Figure 5) to estimate erosion. Sediment moved very little around the Powel property in the three years of monitoring since the bulkheads were removed. Figure 5 illustrates.

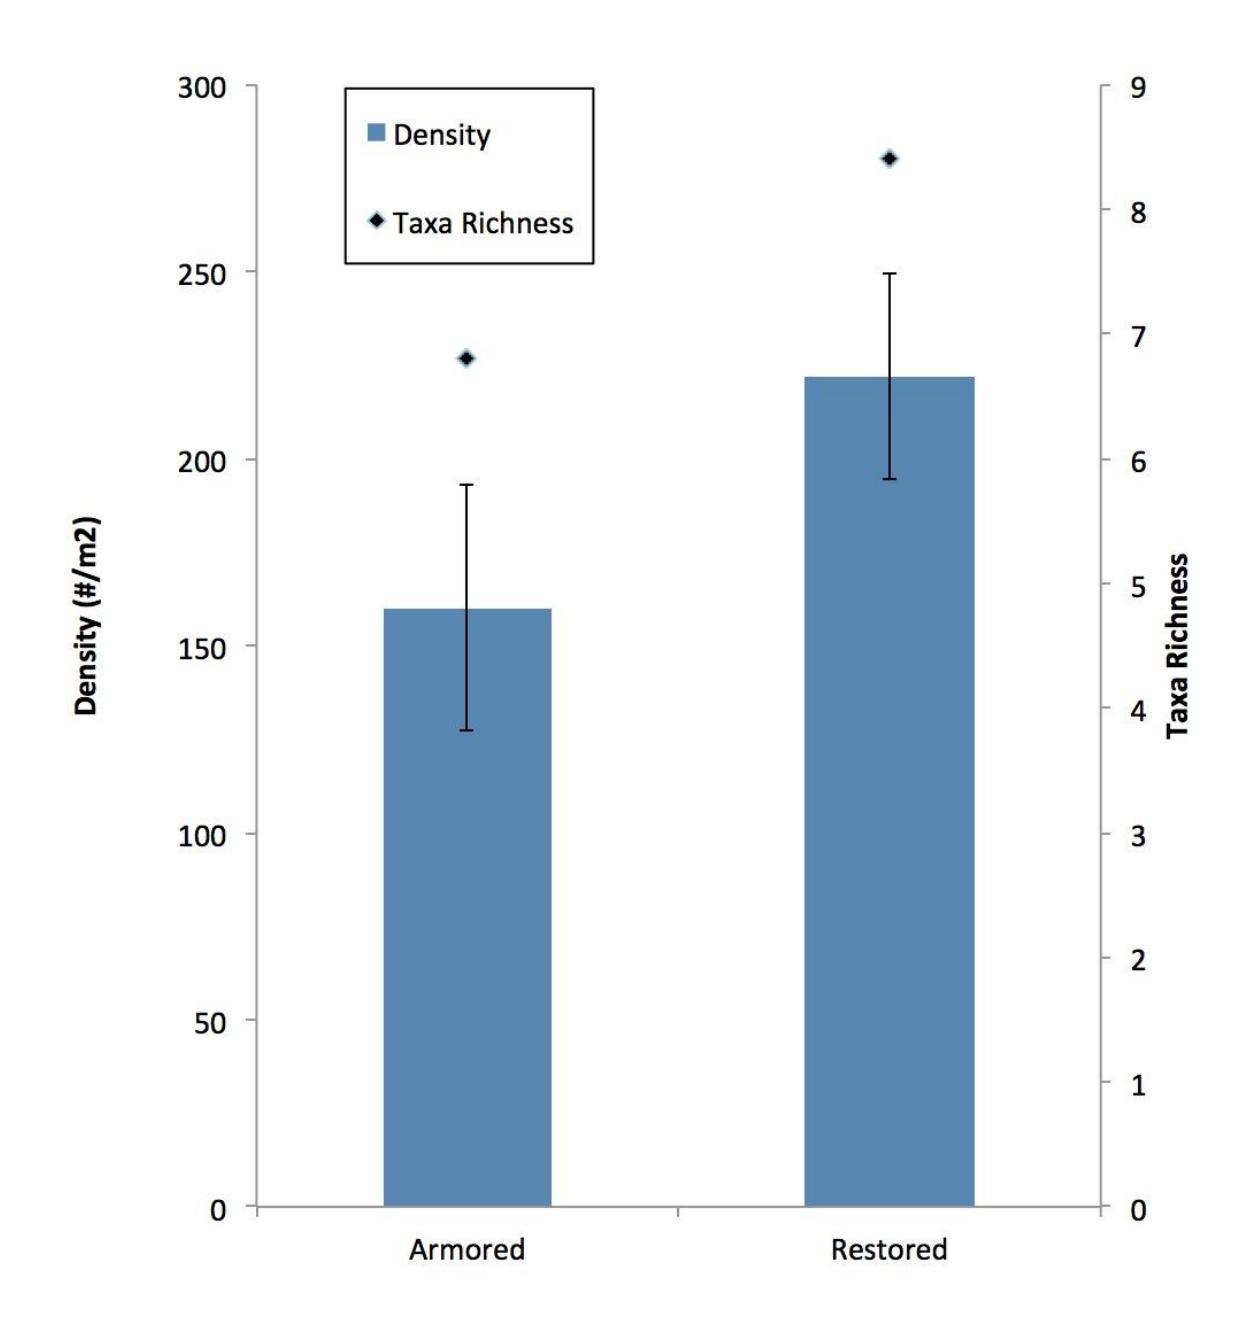
Figure 6. The number of unique insect species ("taxa richness") and the total number of individual insects (density) were both greater at the restored location compared to a location that had a bulkhead and nonnative plants. More insects were observed at the restored site even though 2015 was a drought year which may have affected both plants and insects.

- Overall insect density and taxa richness (number of different taxa) were higher at the restored site than the site with a bulkhead (Figure 6). These results were significant at p<0.05 for density, and marginally significant at p<0.1 for taxa richness. This is an encouraging signature after initial restoration, as the vegetation will continue to grow and support diverse insect communities.

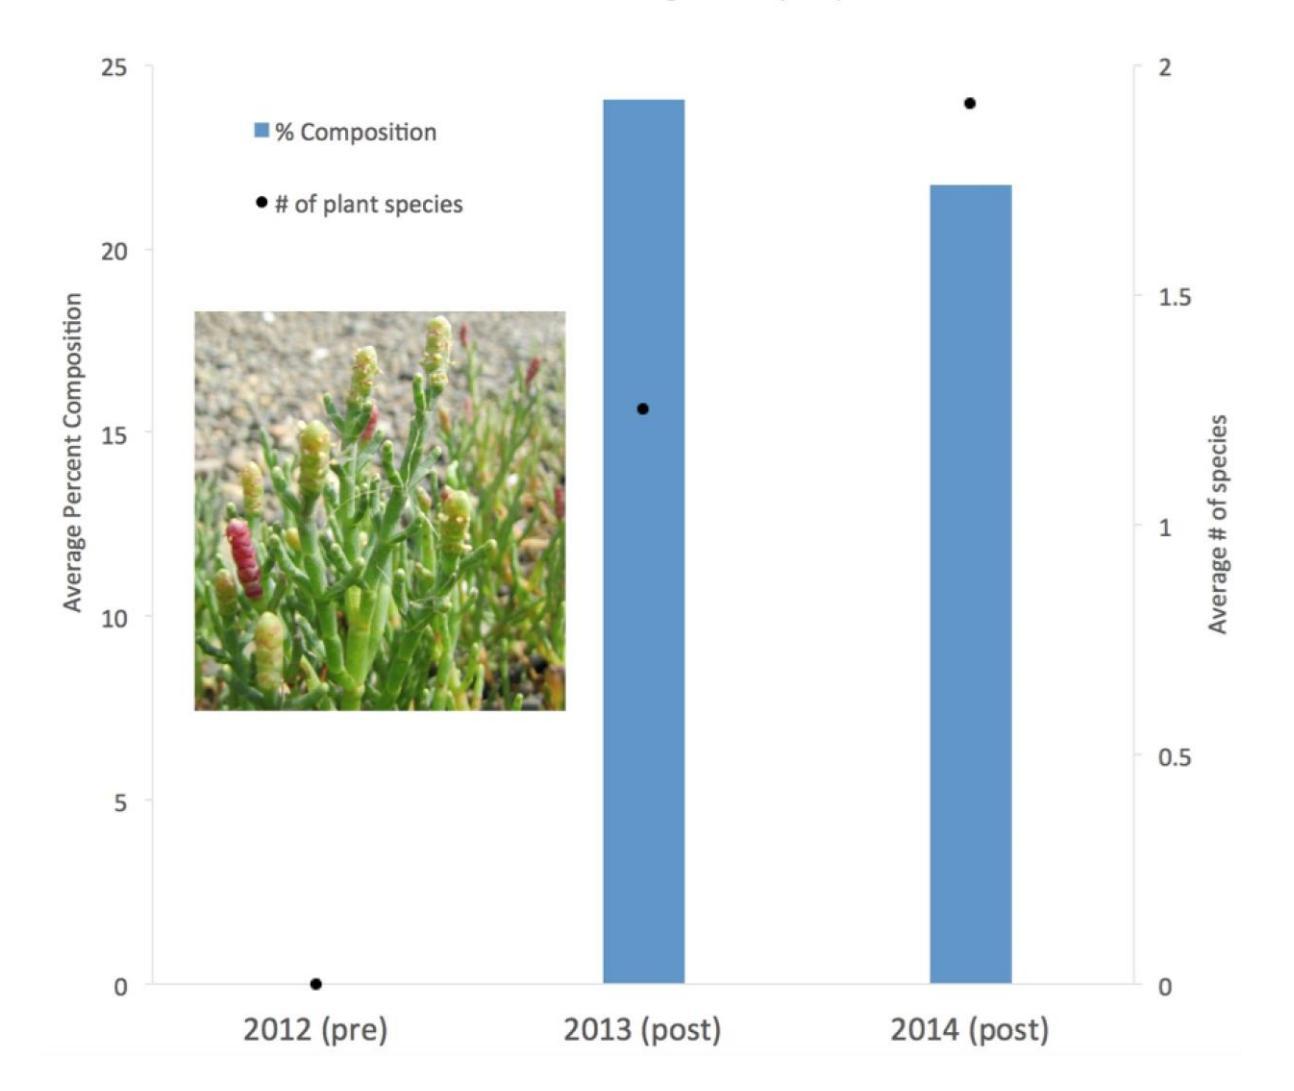
Saltmarsh Vegetation pre/post-restoration

Figure 7. After the bulkhead was removed, saltmarsh plants came back to colonize the restored area. Native plants such as pickleweed dramatically increased the plant cover from 0 to over 20%. Measurements were taken at approximately mean higher high water (MHHW) where bulkheads and fill blocked the beach.

- Across all monitoring transects, the number of salt marsh plant species present increased from 1 species pre-restoration to 3 species after bulkheads were removed (Figure 7). Percent cover of salt marsh plant species was also consistently higher after restoration, as the plants were able to use upper intertidal habitat where that habitat did not previously exist. While natural recruitment of Pickleweed (Salicornia virginica) from existing project seedbed is expected to expand into intertidal area over time, monitoring results indicated that experimental Pickleweed planting in one reach of the
